Department of Mechanical and Aerospace Engineering

Wind Turbine Decommissioning: Mechanical Assessment of Yaw Calipers for Reuse.

A thesis submitted in partial fulfilment for the requirement of degree in
Master of Science in Sustainable Engineering: Renewable Energy Systems and the
Environment

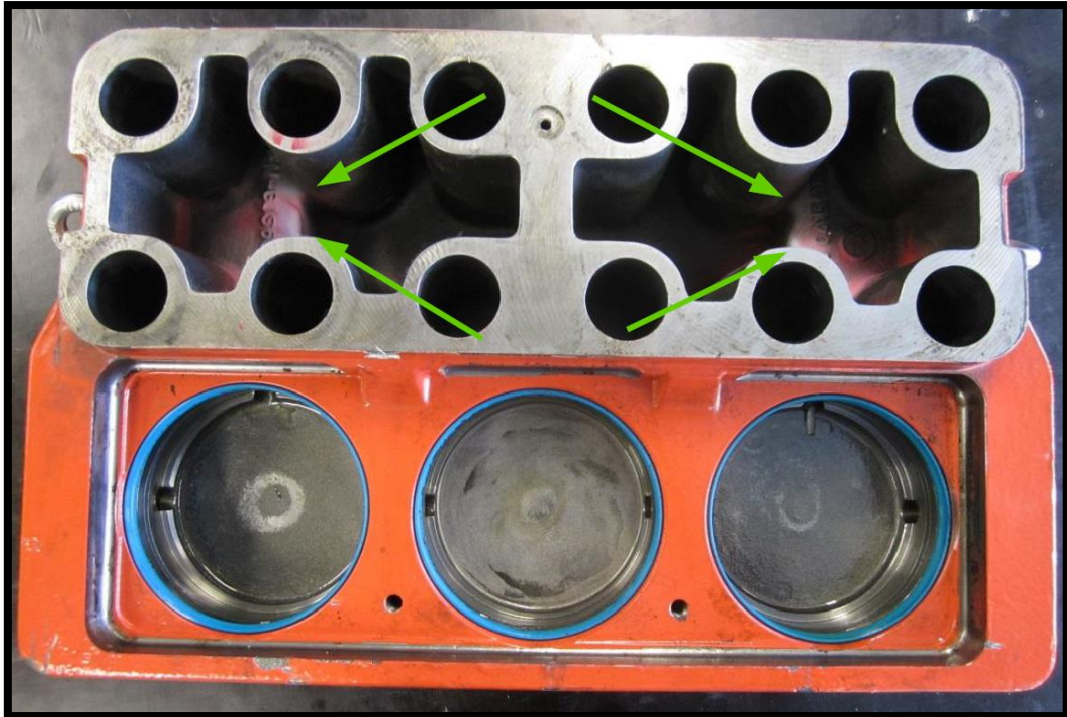
Fatigue cracking has been found within the cavity between the clearance holes on the ledged surface and have been identified through dye penetration, see Figure 4 & Figure 5. These cracks appear in the crested waveform shape typical of fatigue cracking. Other units have experienced fracture at these points resulting in component failure. In an operational environment this could create catastrophic failures within the turbine. As a result, this is currently the largest risk to the component going back into service.

Figure 4: Dye Penetration On Shallowest Section Within The Hollow Section Between Clearance Holes

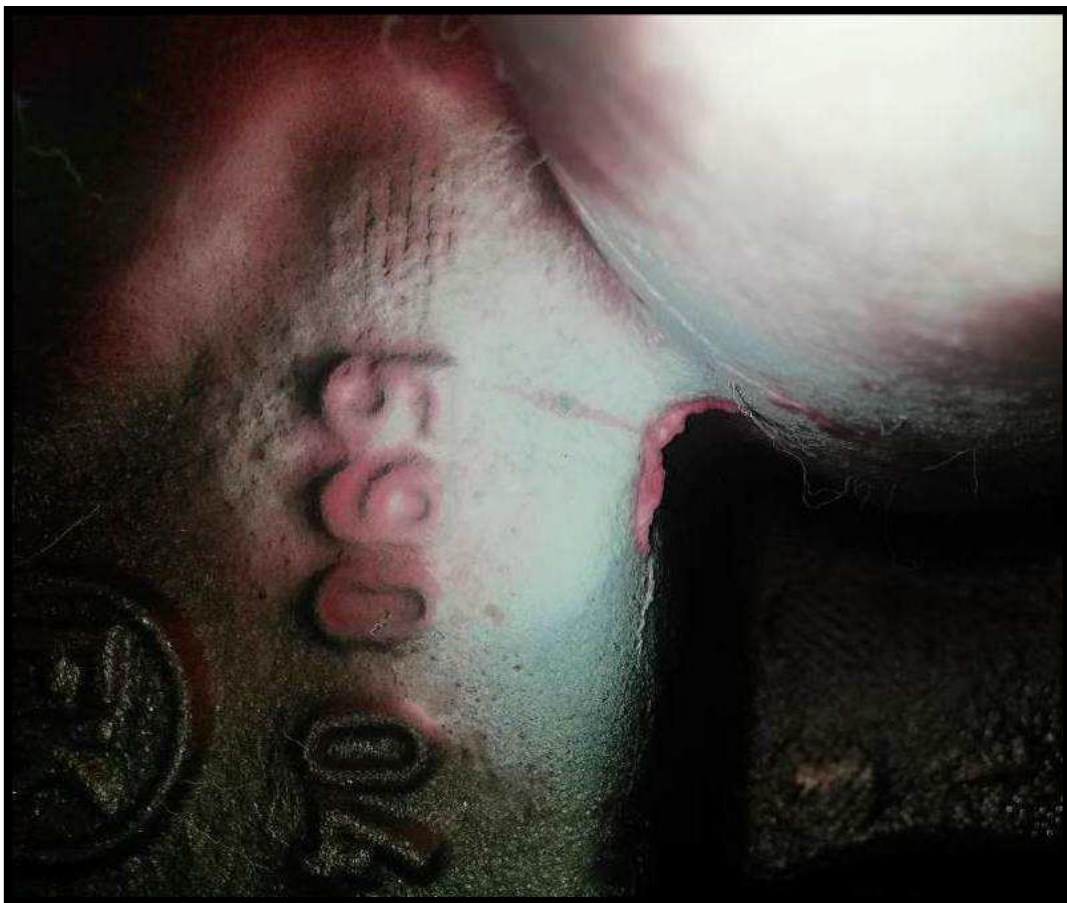
Figure 5: Suspected Fatigue Cracking Identified Through Dye Penetration

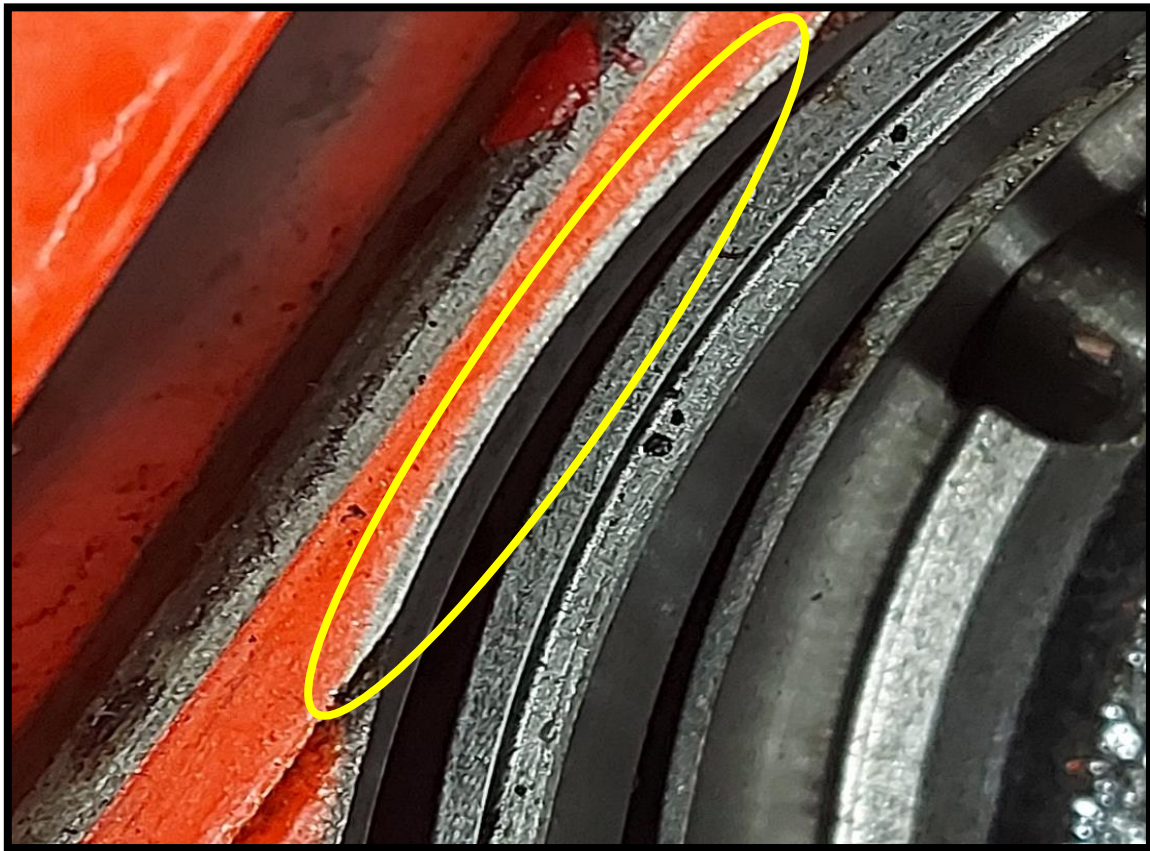
Piston cylinder damage can lead to the undistributed pressure in pistons and therefore will lead to a reduction in efficiency. Over time if this was to worsen then a failure could occur. Typically, form damage of the cylinder is only seen on one of the pistons in a caliper half. This can also lead to unsymmetrical damage of seals leading to their failure which in turn increases Operation and Maintenance (O&M) costs. Figure 6 highlights in yellow the start of damage to the piston cylinder. FEA analysis conducted by Siemens on the structural properties of the component under operational conditions show that the cylinders would experience this type of damage through its lifetime, see Figure 7.

Figure 6: Piston Cylinder Damage

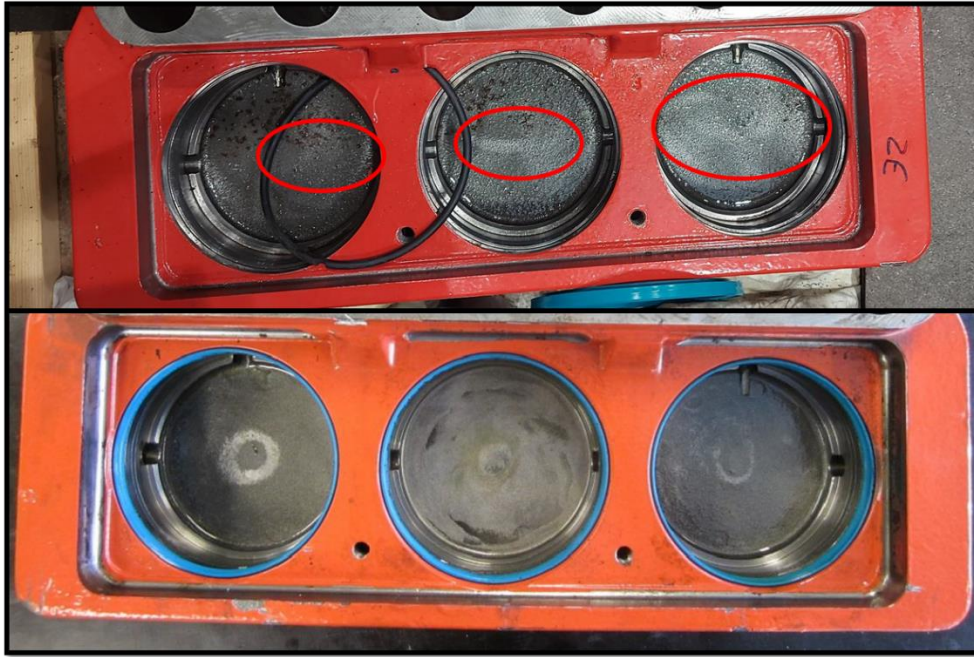
The surface at the bottom of the piston cylinders have shown signs of wearing when compared to new components, see Figure 8. If the surface is being worn down during operation this could lead to oil contamination with metal particles damaging internal components. On the new caliper the bottom on the cylinders have casting defects which appear to have been made by mould movement during casting. Other calipers have shown that grinding has taken place in these areas indicating the removal of these defects. However, these surfaces compared to that in Figure 8 are more rough in nature.

Figure 8: Top - New Caliper with Cast Skin, Cast Defects in Red; Bottom - Used Caliper with Cast Skin Damage

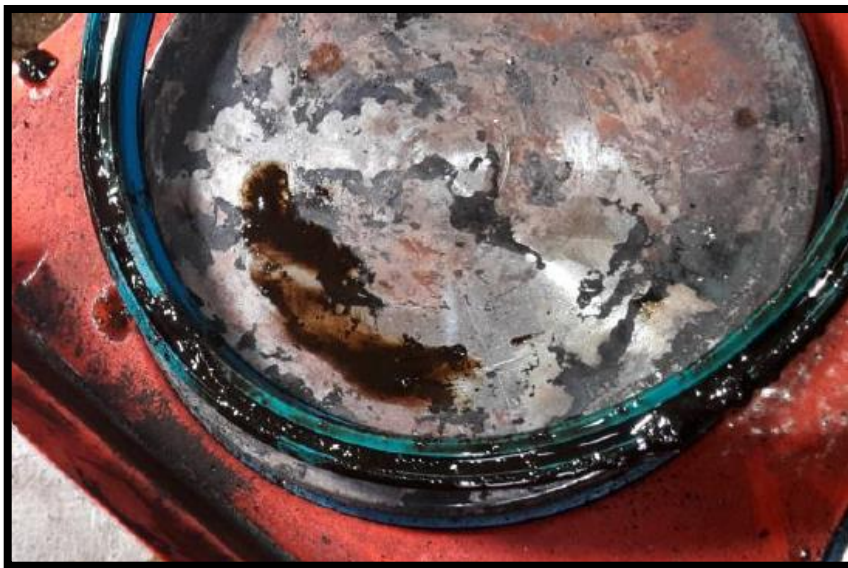
Hydraulic fluid contamination has been apparent from the strip down of the calipers with the fluid showing the oil to be viscous with oil sludge present. This could be from either external or internal sources but overall result in the failure of seals. The operator where Renewable Part Ltd source their components have stated that oil leaks are common and unattended to. This can cause further contamination, reducing the efficiency of the system and leading to higher rates of component wear. Figure 9 showcase the hydraulic fluid contamination observed.

Figure 9: Oil Contamination Seen During Component Strip Down

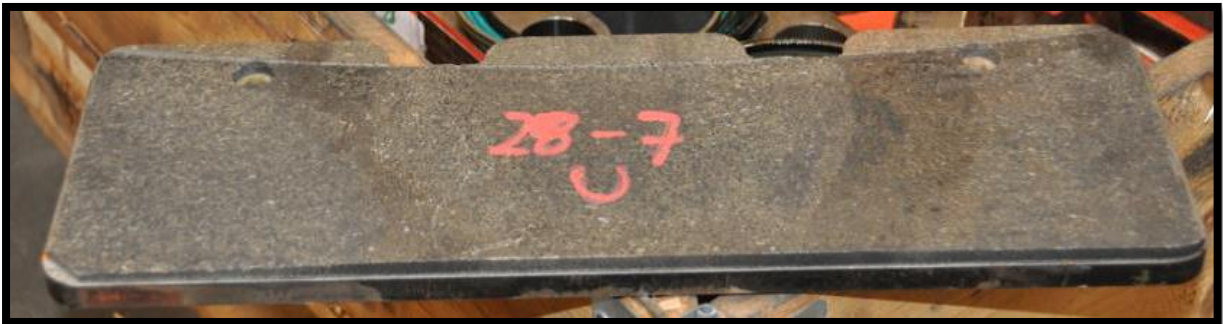
Brake pads taken from calipers that had been in operation show uneven wear across the brake pad surface, see Figure 10. This is an indication of non-uniform loading across the surface.

Figure 10: Brake Pad Showing Uneven Wear

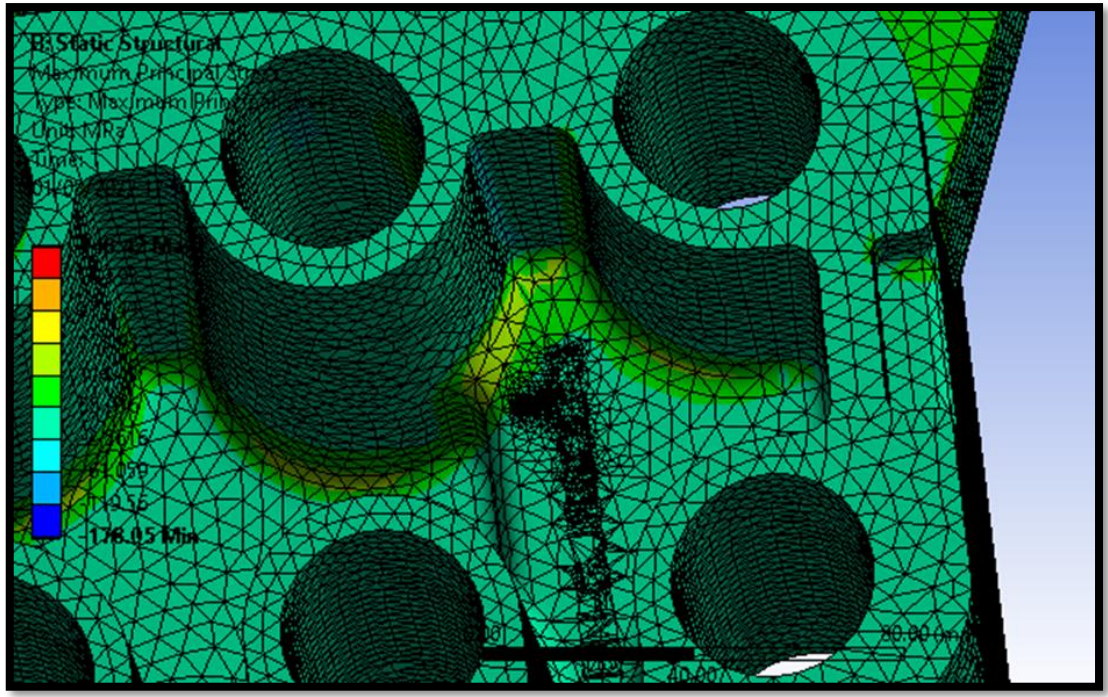
From Loading 1 there was no evidence of fatigue within the cavity at the holes. This area had the lowest deformation for the whole part, see Figure 34. A stress concentration was noted at the corner near the stamping, see Figure 35, which is at the same location as the suspected crack in Figure 5. Even with this stress concentration no fatigue damage appeared in this area. This would indicate that the component is unlikely to fail at this location. For this loading condition failure was estimated to occur on the underneath of the part at the supporting fins, see Figure 36.

Figure 35: Stamped Caliper Model with Loading 1 - Stress Concentration on Cavity Ledge Corner

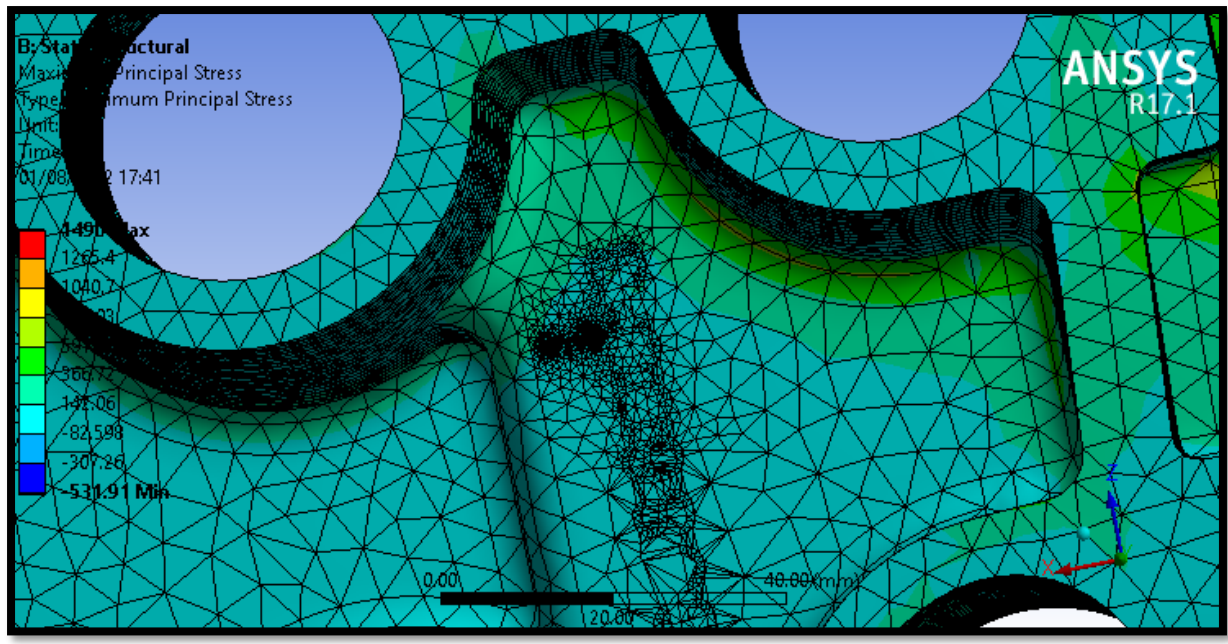
Loading 2 showed a similar story to that of loading 1 in terms of deformation with the ledge surface experiencing the lowest values, see Figure 37. A stress concentration of bigger magnitude was seen in the corner near the stamping, see Figure 38. When looking at fatigue damage Loading 2 resulted in damage being seen on the ledge surface, see Figure 39. However, this was not the only damage area with areas underneath the bores likely to fail first under these loading conditions, see Figure 40. This shows that an undistributed loading would cause failure at the cavity location but under the conditions as per Loading 1 this would not be the case. As

Figure 38: Stamped Caliper Model Loading 2 - Stress Concentration on Ledge Surface

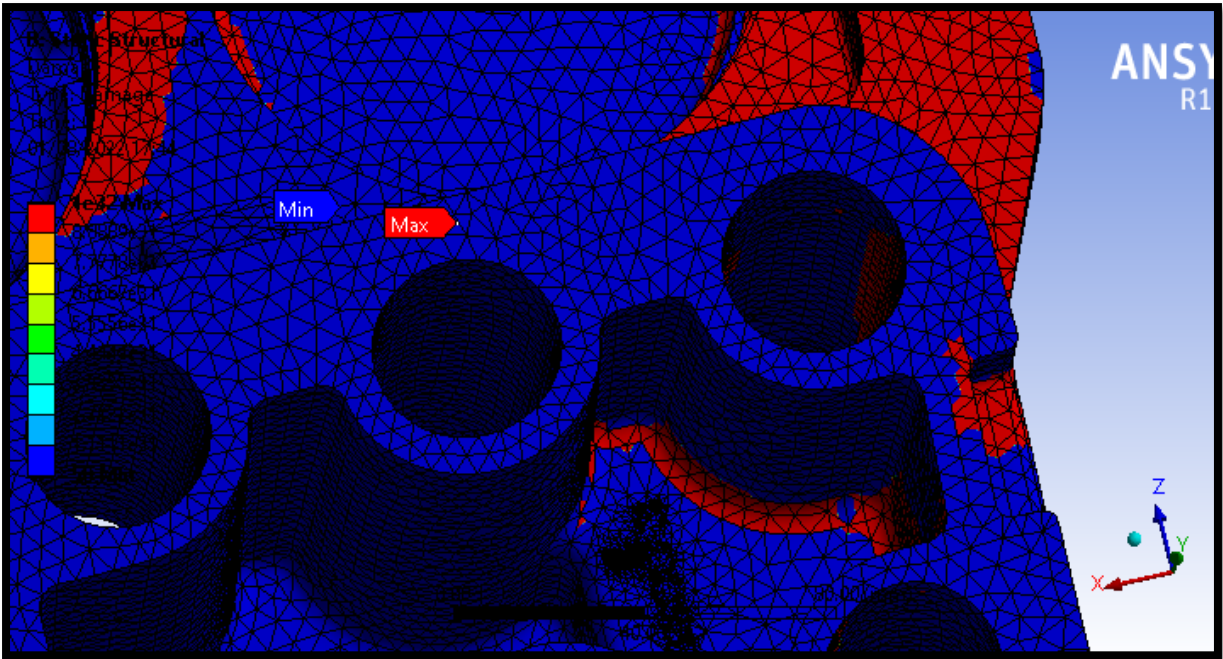
fatigue failure occurs at stresses lower than that of the materials strength by applying a low load at the position seen in Loading 2 may cause the component to fail as per reported by Renewable Parts Ltd.

Figure 39: Stamped Caliper Model Loading 2 - Fatigue Damage on Ledge Surface

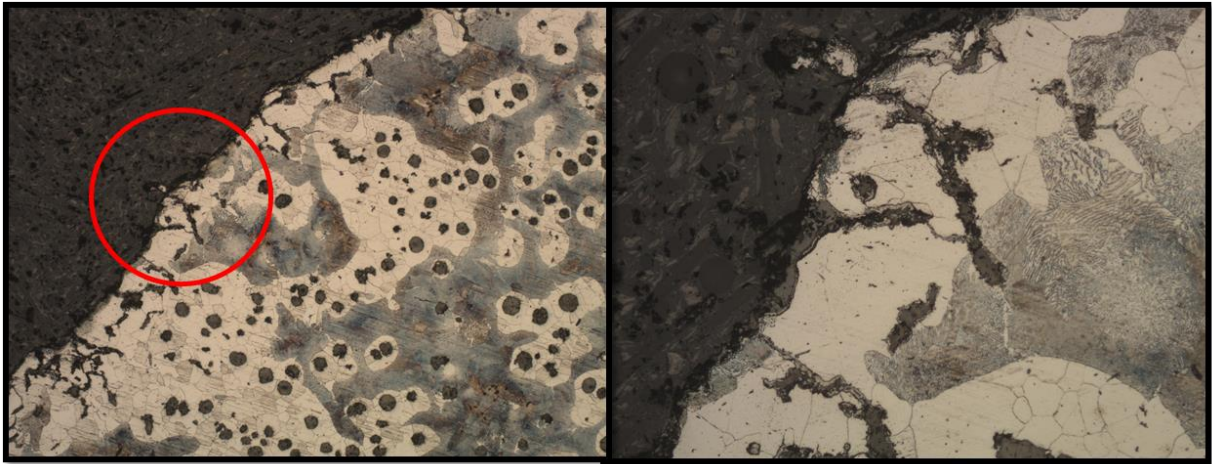
Sample B was analysed to find any evidence of fatigue cracking or possible causes. The main area of focus was geometry such as an internal hole, the embossed stamping and the casting surface. The first area looked at was the corner surface, see Figure 46, this showed the presence of more flake graphite compared to that of the unground surface in the bores. No cracking was identified in this area.

Figure 46: Corner Surface: Left – x50 with Area of Interest Highlighted in Red, Right – Area of Interest at x200

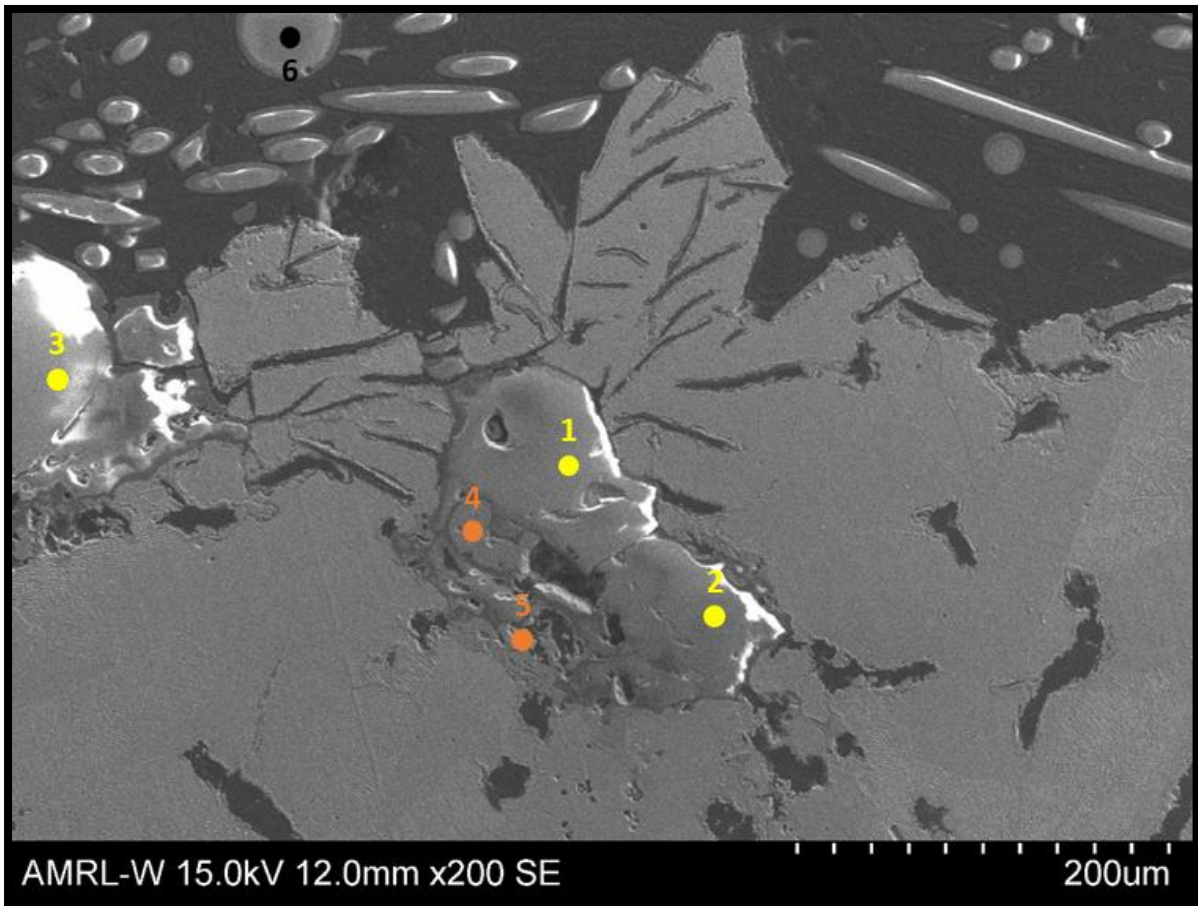
Figure 52: SEM Image of Suspected Sand Grain on Side Surface x200
