West Whitlawburn Housing Co-operative Thermal Imaging Report

Msc Renewable energy group – Nikki Homfray, Gavin Lavery, Aga Bachleda-Baca, Calum Love

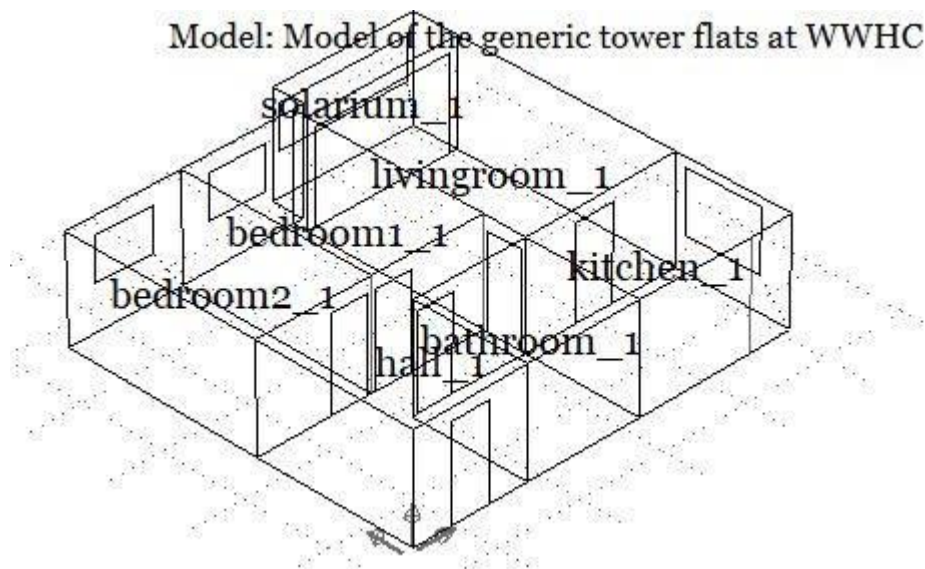
Figure 1: ESP-r flat model

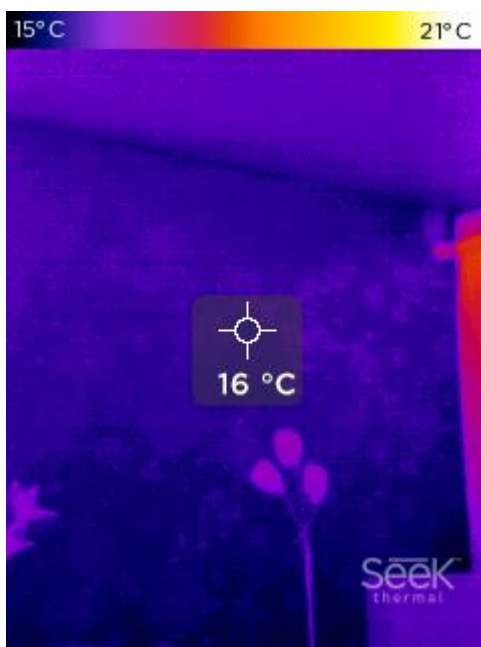
Figure 12: External wall in living room
