**Developing a Methodology to Identify Discrepancies in  
Comparisons Between Predicted and Actual Energy Use  
in Non Domestic Buildings:**

**Lews Castle College Case Study**

A thesis submitted in partial fulfilment for the requirement of degree in  
Master of Science in Renewable Energy Systems and the Environment  
2010

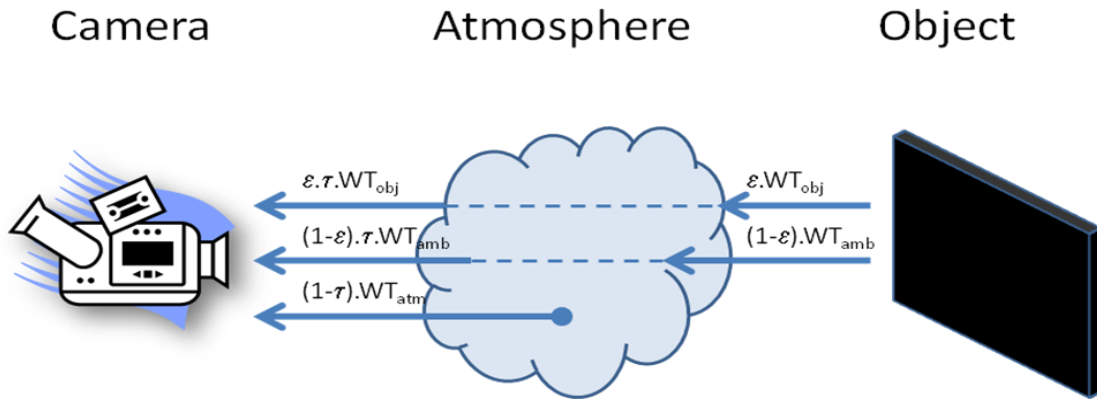
**Figure 2: Illustration of thermal imaging capture process. Based on a figure in Claes (2001).**

Figure 2 illustrates where the three above equations originate in the thermal imaging process.

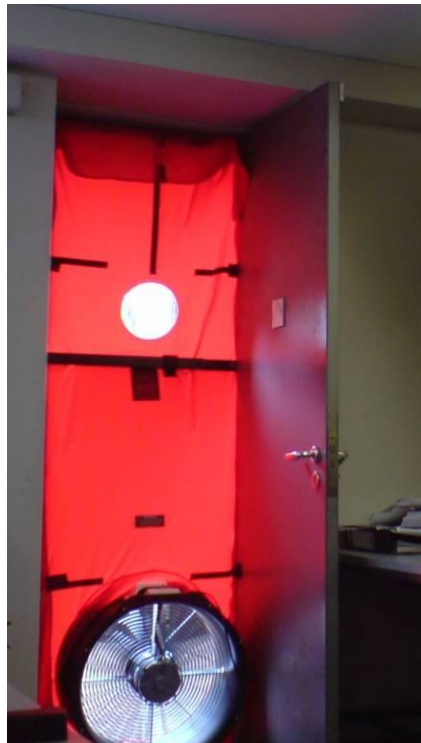
**Figure 5: Set up of the air pressure testing kit on the classroom E005 in Engineering Building**

linked to the pressurisation fan. Figure 5 illustrates how the equipment was set up for the experiment.

The air pressure testing kit was then kept on at 50Pa and used in conjunction with convective heaters and the thermal imaging camera to identify the areas of leakages in the room.

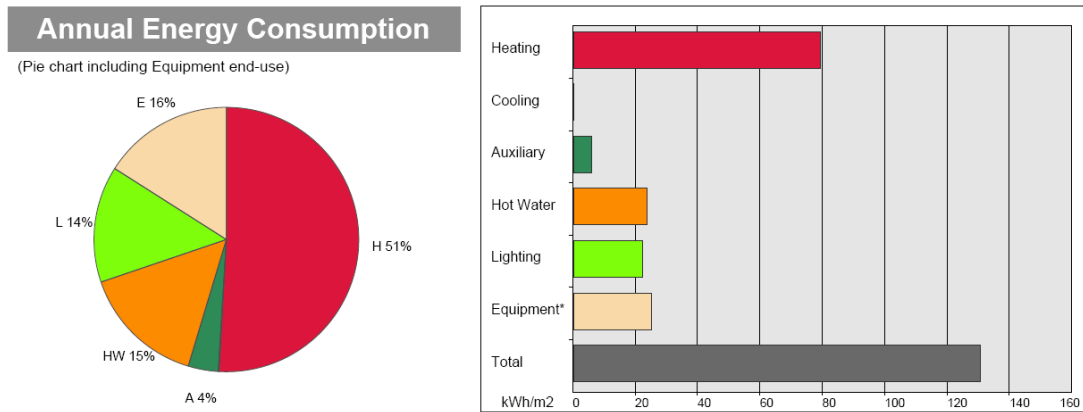
**Figure 6: Annual energy consumption obtained from SBEM for the Rural Building**

It was also seen in the SBEM analysis that lighting contributes significantly to the electricity usage in the energy consumption. In the Engineering building SBEM output document, it was seen to contribute nearly a quarter of the total energy consumption. Other aspects that also contributed notably to the energy consumption were from equipment and hot water demand. Figure 6 shows the annual energy consumption in the Rural Development Building which gives a fair indication of how the campus is performing.

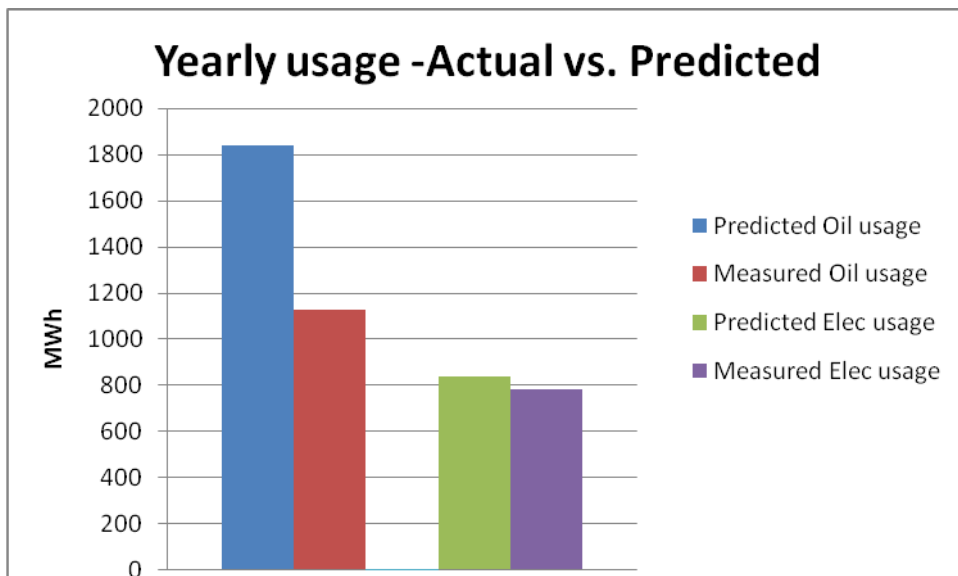
**Figure 8: Yearly comparisons of yearly actual and predicted use broken down by fuel type**

A yearly comparison was also carried out of the energy uses for heating oil and electrical usage. It can be seen that the predicted heating oil usage is approximately 63% more than actual heating usage. The prediction shows that there is 547.69kWh/HDD which is 191.47kWh/HDD more than the actual usage. This is quite significant over prediction and is the primary reason why the EPC data is higher than measured energy use. It can be seen that there is only a small over prediction in the electrical usage.

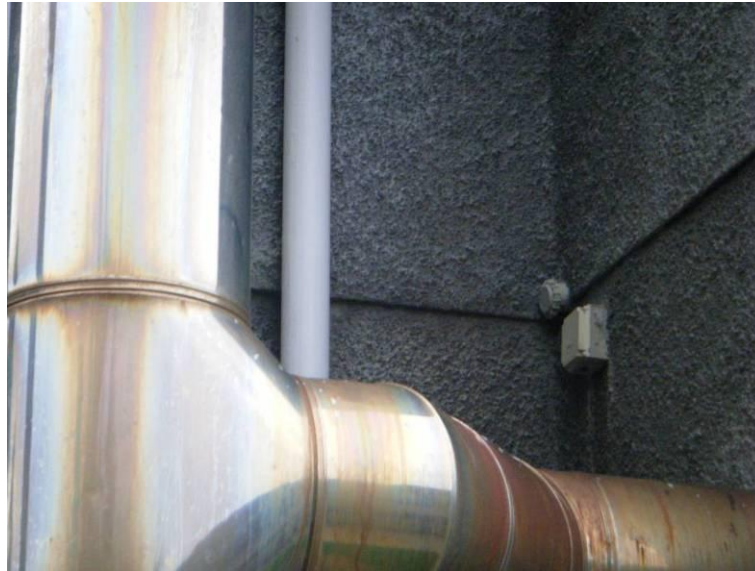
**Figure 9: Outside temperature sensor situated too close to flue exhaust pipe from boiler house**

the positioning of the discussed outside temperature sensor. This finding is similar to issues found by Donald (2010) which cites poorly positioned sensors that can adversely affect energy consumption.

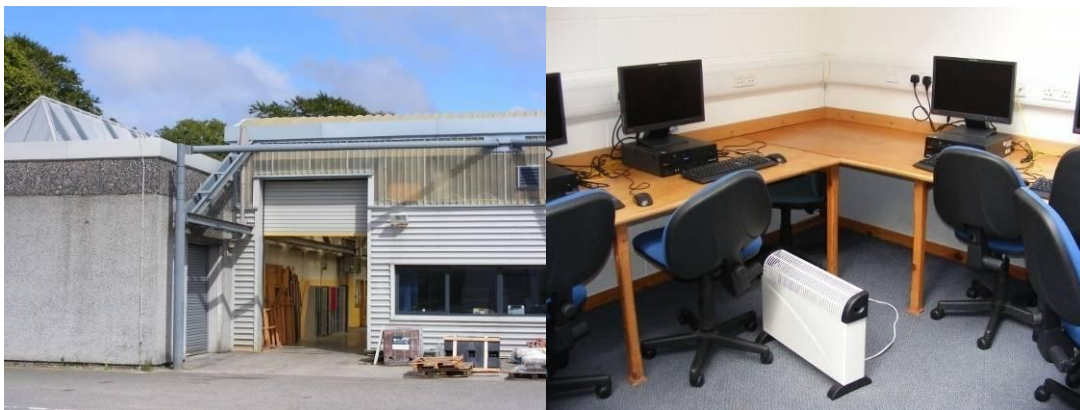
**Figure 13: Engineering Building glass/fibreglass roof (left) and use of electrical convective heaters (right)**

Clearly, the Engineering Building is a building with great thermal issues. With such heat loss problems in cold weather and convective heaters adding to the electrical load, it should be expected that both predicted heating and electrical load would be lower than actual usage. However, this was not the case and will be analysed further into this report.

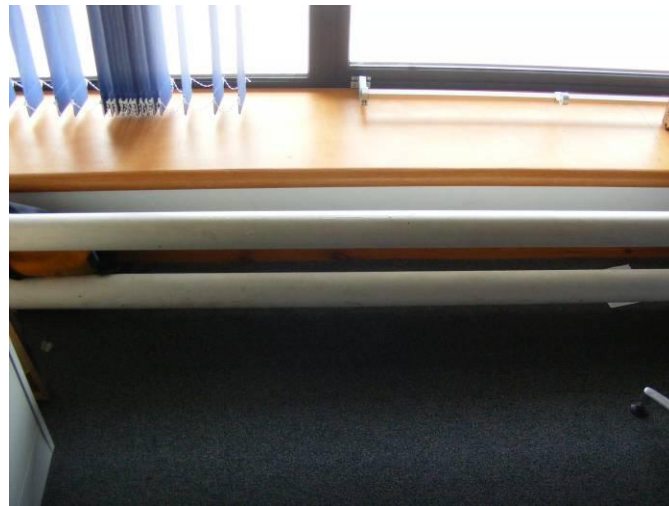
**Figure 14: Heating pipe running along the upper floor of the Rural Building**

issues in the winter; however, it can generate overheating in the rooms in the summer. Another aspect that was noted from the visual inspection of the building was that most of the building has a suspended ceiling. This may cause problems with heat losses through the ceiling and roof as there are a few gaps in the suspended ceiling tiles which were not fitted properly.

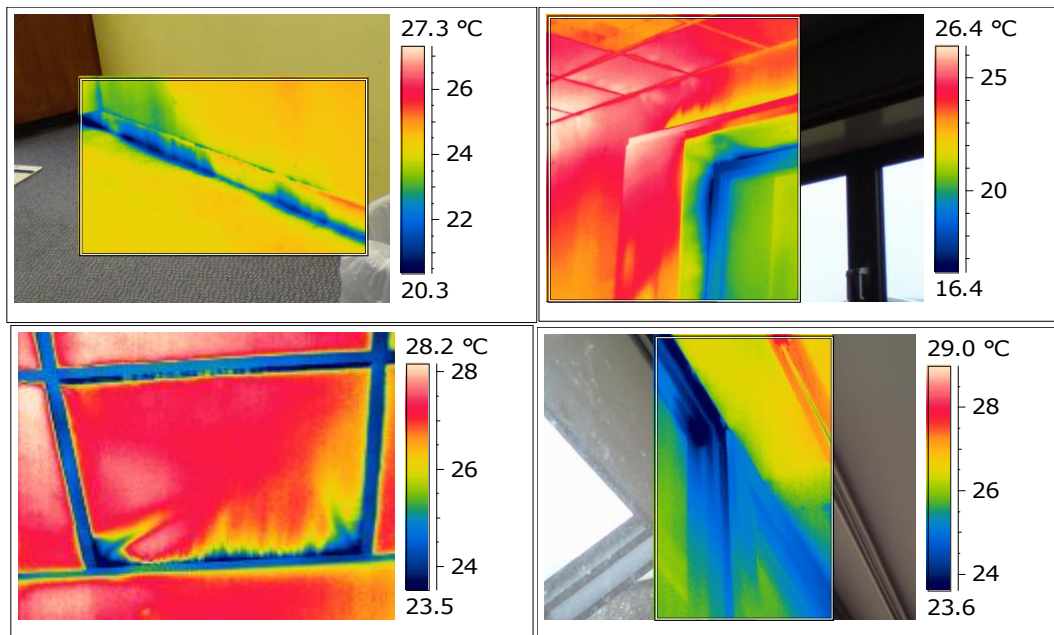
**Figure 16: Examples of heat losses identified through internal thermal imaging survey carried out in conjunction with the blower door kit**

In the classrooms in the Engineering Building, there were a number of areas that were a cause for concern in terms of heat losses. It was seen that in one of the classrooms in this building, E005, there were leakages occurring through poor workmanship. It was seen that there was air escaping through cracks in some surface joins within the building space envelope, such as with floor skirting or walls. In addition, it was seen that there was an issue with leakages occurring from poor airtightness in windows and doors in the room. An example of both areas of air leakages found can be seen in Figure 16. The results from other classrooms in this building and the other campus buildings showed similar problematic airtightness results to E005.

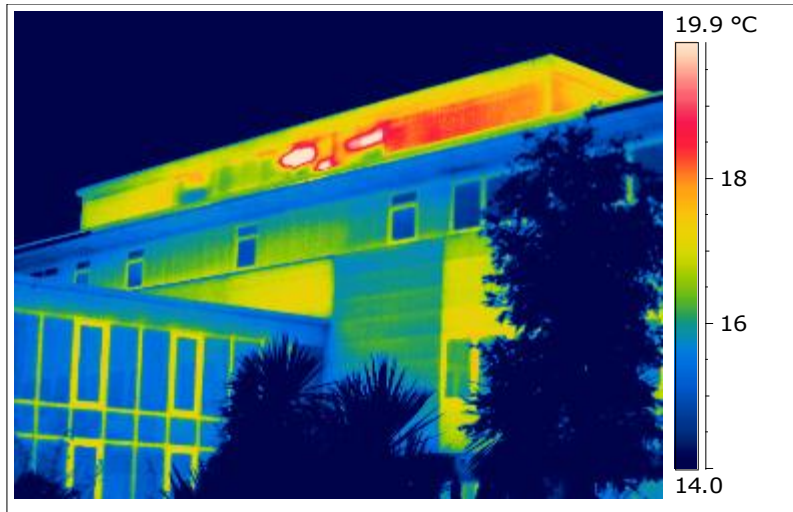
**Figure 17: Thermal image of AHU during the bank holiday**

Thermal imaging surveys carried out externally on the campus buildings produced some interesting results. It was seen that during the bank holiday weekend, when the College was closed, that the Air Handling Unit (AHU) was still in operation at the beginning of the holiday. This can be observed in Figure 17 which shows the AHU on in the roof of the C block of the facilities building emitting heat, indicating it is still in operation during this time.

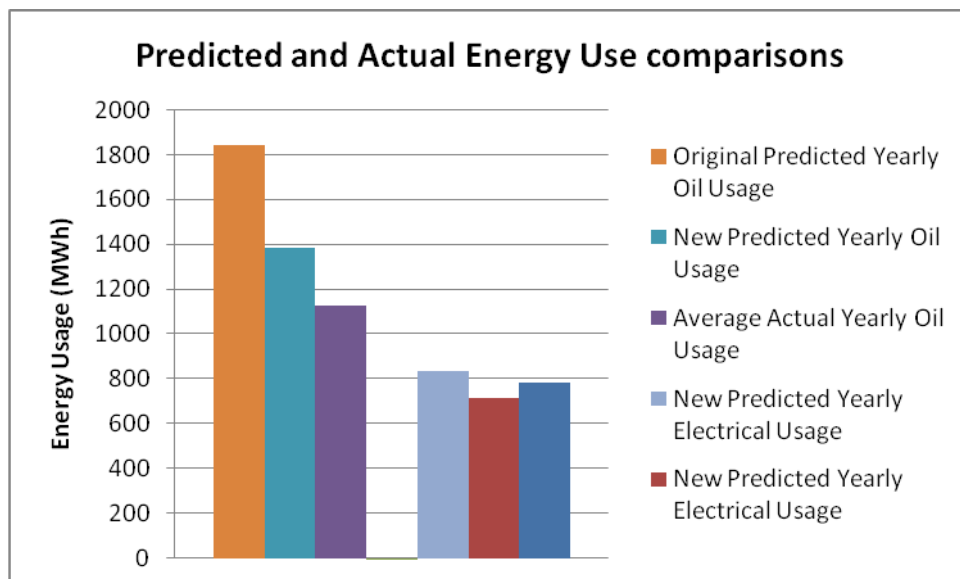
**Figure 21: Annual comparisons of energy usage (by fuel type) of original and new EPC values with actual usage**

It was noted, with the new detailed EPC results, that the electrical usage was now under-predicted by nearly 10% compared to the actual energy use. This was a change of an over-prediction from the original EPC data. However, the oil usage prediction from the new simulations showed that it was still being over-predicted, by 22%, compared to actual heating data. Despite this, the new predicted heating loads are lower than that of the original prediction figures. The new prediction produces a value of 411.12kWh/HDD, which is 54.9kWh/HDD more than is actually being used. This is a dramatic improvement to the original prediction. It has to be noted that the occupancy levels in the SBEM database would be higher than those of the actual campus building. This would mean, overall; the actual energy usage should be lower than that of the SBEM predictions. This conclusion seem to match well with Egan (2009) who regarded occupancy levels as one of the reasons that discrepancies occur between predicted and actual energy use. The comparisons of the new and original predicted energy use to the actual energy usage can be seen in graphical form in Figure 21.

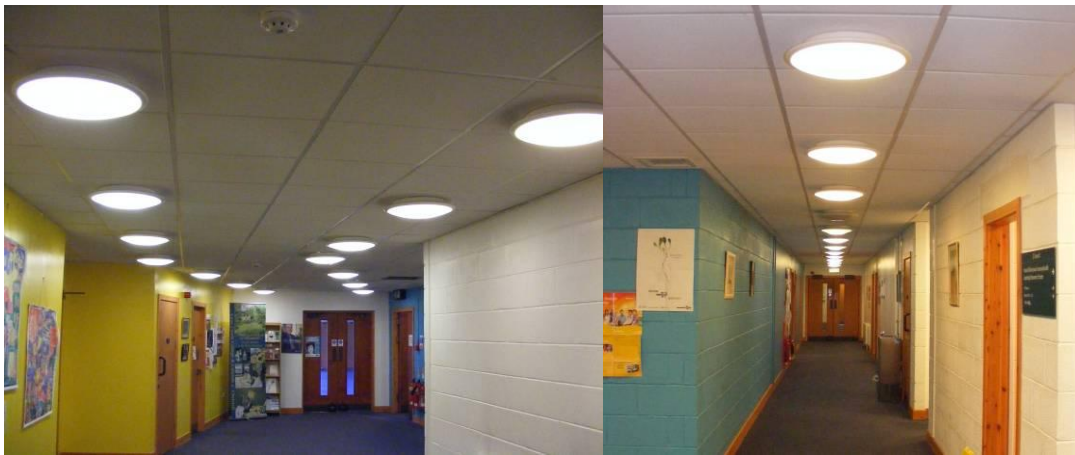
**Figure 25: Images of excess lighting in the Facilities Building**

There have already been recommendations on how the building could be improved suggested by the EPCs. These suggestions include adding time control to the heating system, replacing halogen light bulbs to more energy efficient ones and an efficiency survey on the heat generation system. The EPCs also recommended that some areas of the campus have too much lighting fixtures for a given area and should be reduced. Indeed, visual inspections of this building brought up some observations that could affect energy efficiency. It was seen that, in several corridors in the building, there was over use in lighting in these areas. This is predominant in the Facilities Building, which can be illustrated in Figure 25.

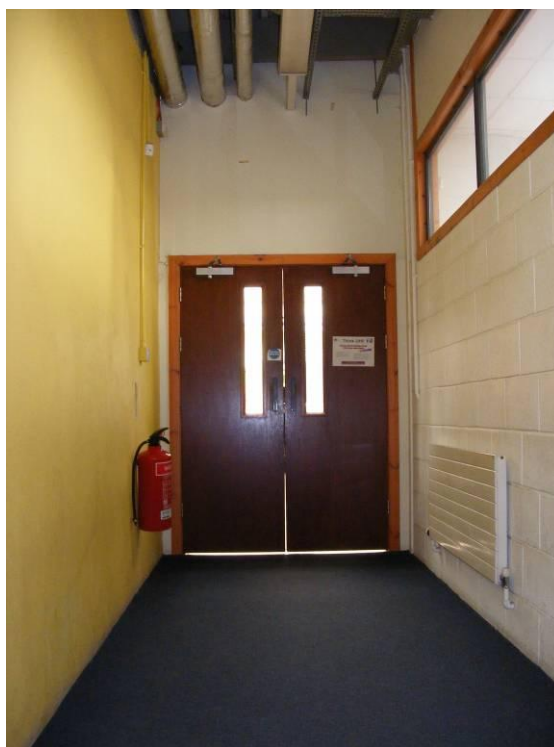
**Figure 26: Image of doors leading from Facilities Building to Engineering Building. Gap from floor to bottom of door is 15mm**

Short term measures to improve energy efficiency, found through the analysis carried out in this report, is to improve airtightness in the campus buildings. This holds true especially for the Engineering and the Facilities Building. It was seen that around these buildings there were issues with workmanship in some areas. This was observed in thermal images on window seals and blower door tests in the rooms indicating leakages in rooms. Replacing poorly fitted ceiling tiles around the campus can help with heat losses throughout the campus. Poor workmanship was also apparent through visual inspections. It was observed that there were large gaps on some doors which would affect energy efficiency. This is illustrated in Figure 26 where the gaps between the doors and the ground are apparent. It was seen that some doors had a gap of up to 20mm from the bottom of the door to the floor. Draughtproofing of these areas should help with energy efficiency with little financial burden.

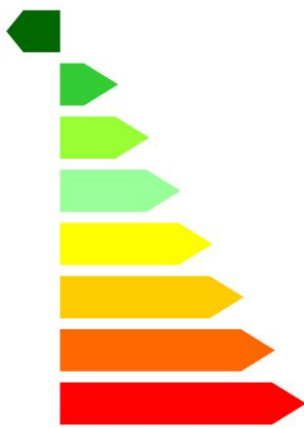
Figure C-1: Energy Performance Certificate for Engineering Building

Building Energy Performance		Scotland
<b>Energy Performance Certificate</b>	Calculated asset rating using iSBEM v3.4.a [SBEM]	Building type Further education universities

<b>Carbon Neutral</b>	
	<b>A</b> (0 to 15)	
	<b>B</b> (16 to 30)	
	<b>C</b> (31 to 45)	
	<b>D</b> (46 to 60)	
	<b>E</b> (61 to 80)	
	<b>F</b> (81 to 100)	
	<b>G</b> (100+)	
		<b>Excellent</b>
		<b>D</b>
		<b>Very Poor</b>
<b>Carbon Dioxide Emissions</b> The number refers to the calculated carbon dioxide emissions in terms of kg per m <sup>2</sup> of floor area per year		<b>53</b>
Approximate current energy use per m <sup>2</sup> of floor area:		<b>173 kWh/m<sup>2</sup></b>
Main heating fuel: Oil		Building Services: Heating with Nat. Vent.
Renewable energy source:		Electricity: Grid supplied
<b>Carbon Dioxide is a greenhouse gas which contributes to climate change. Less Carbon Dioxide emissions from buildings helps the environment.</b>

<b>Benchmarks</b>		
A building of this type built to building regulations standards current at the date of issue of this certificate would have a rating:		<b>32</b>

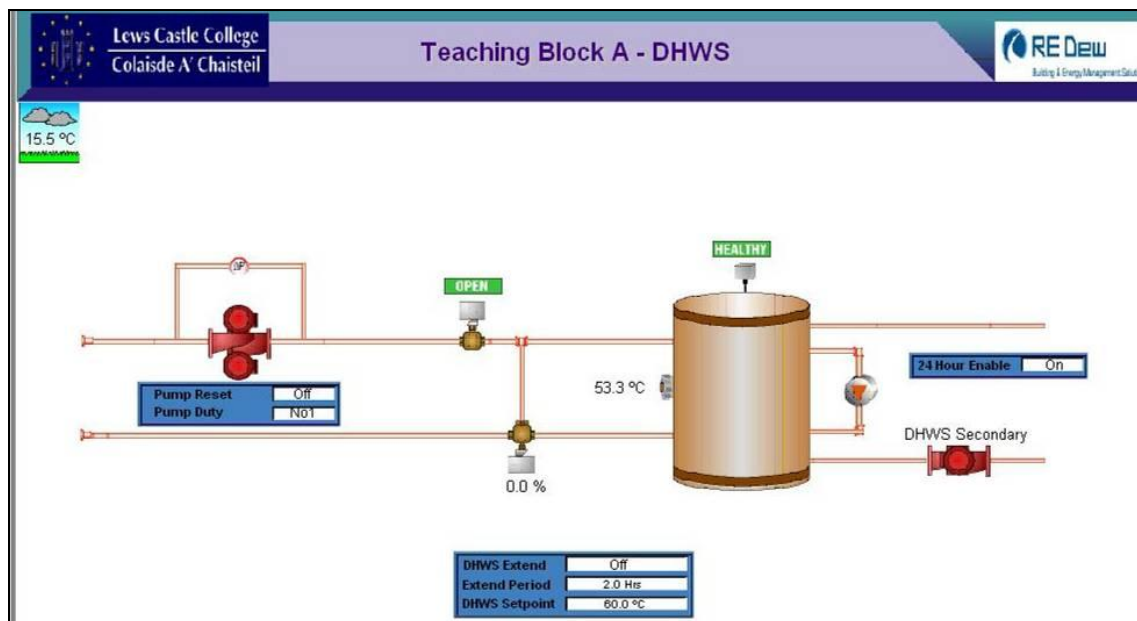
Figure E-2: Facilities hot water system (Block A)

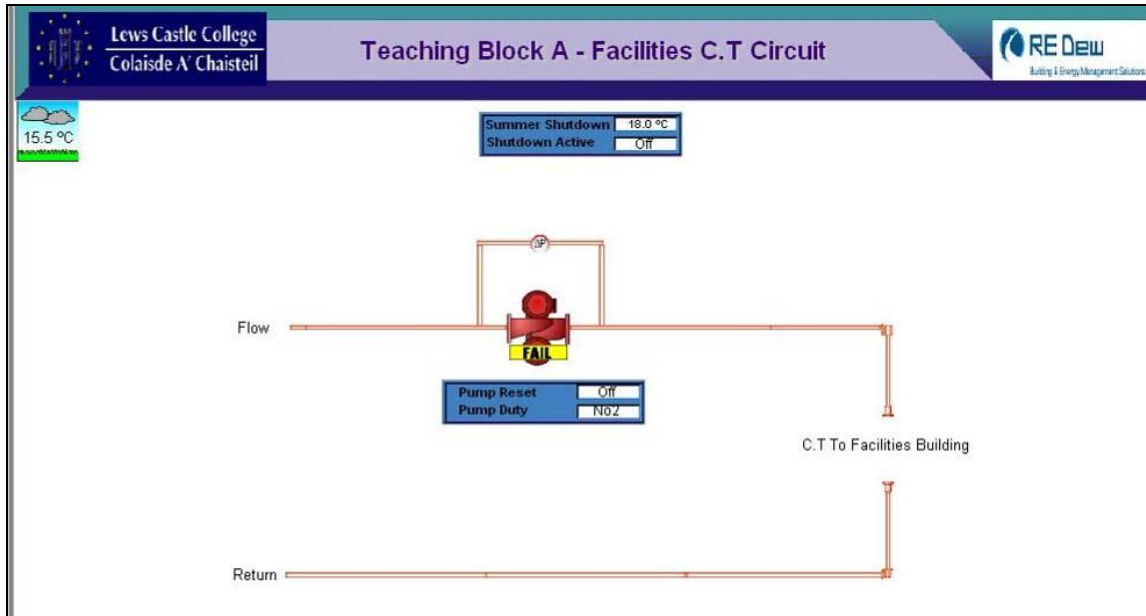
Figure E-3: Facilities heating circuit (Block A)

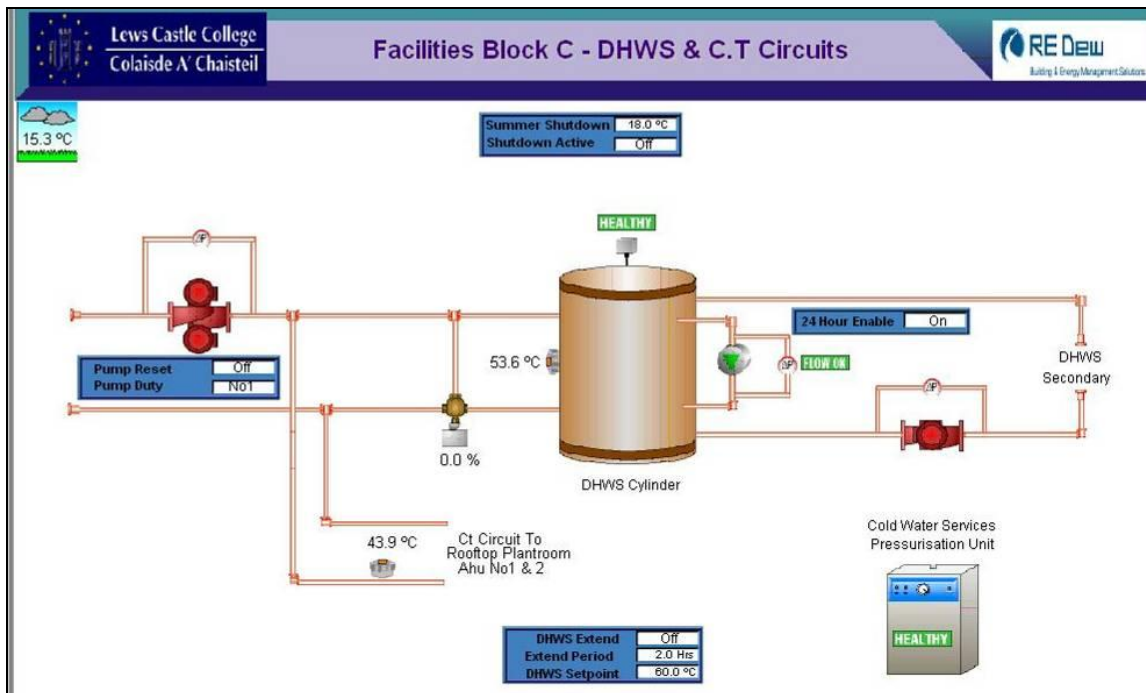
Figure E-6: Facilities hot water system (Block C)

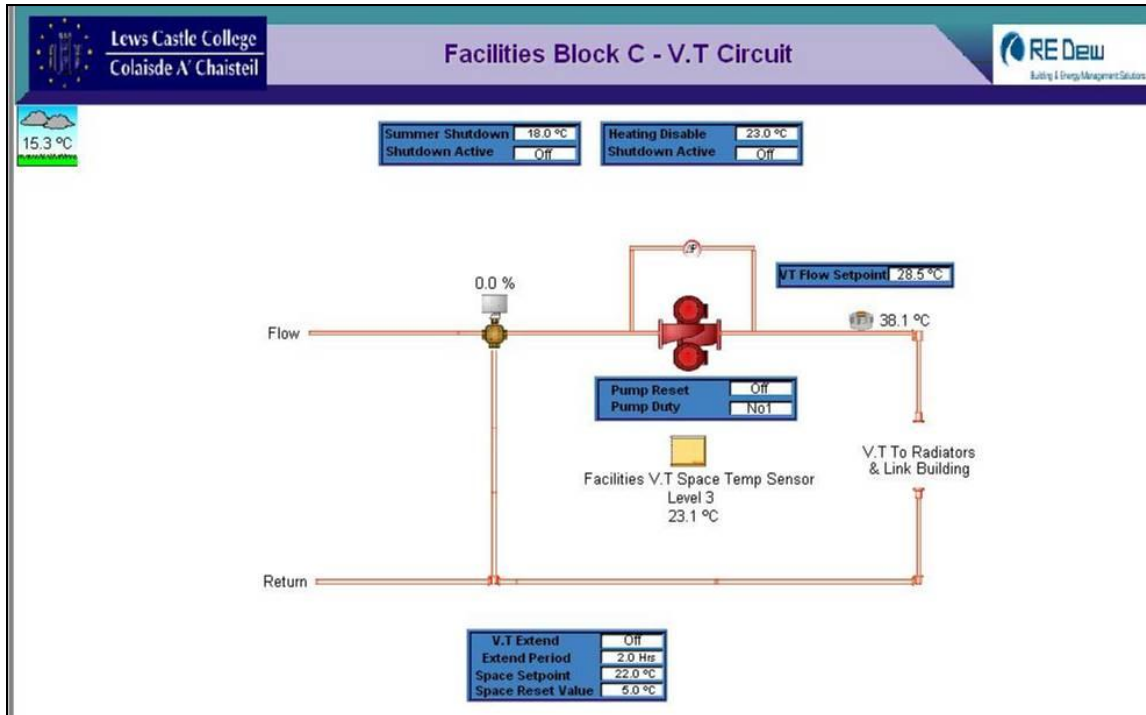
Figure E-7: Facilities heating circuit (Block C)

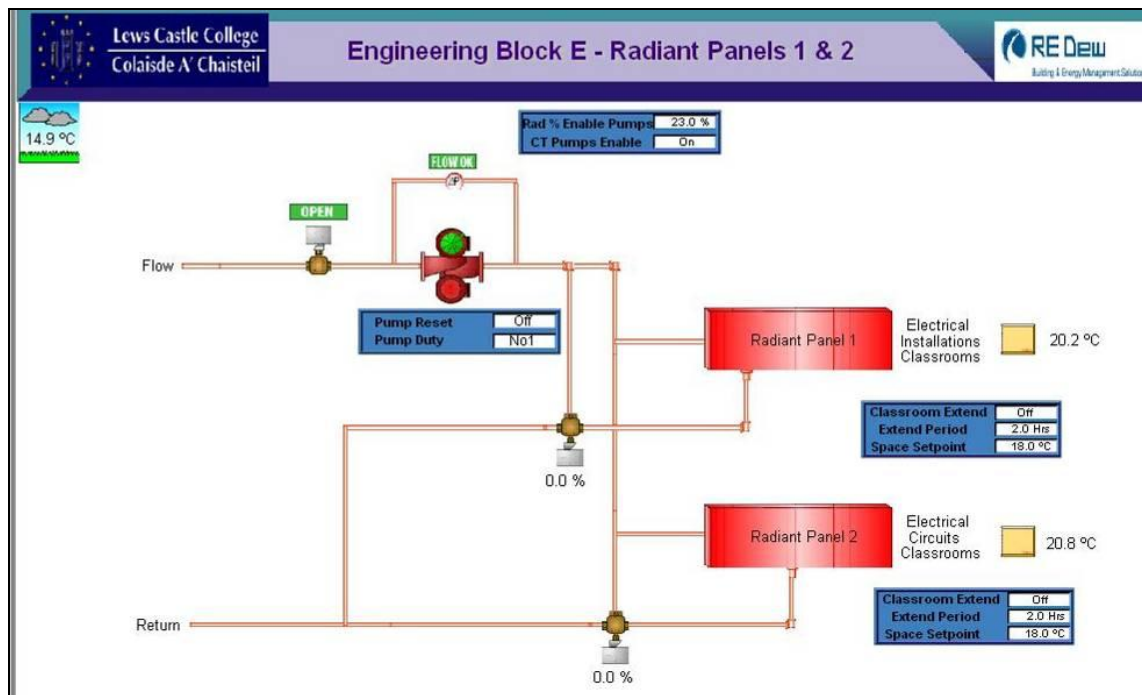
Figure E-8: Engineering Building heating circuit 1

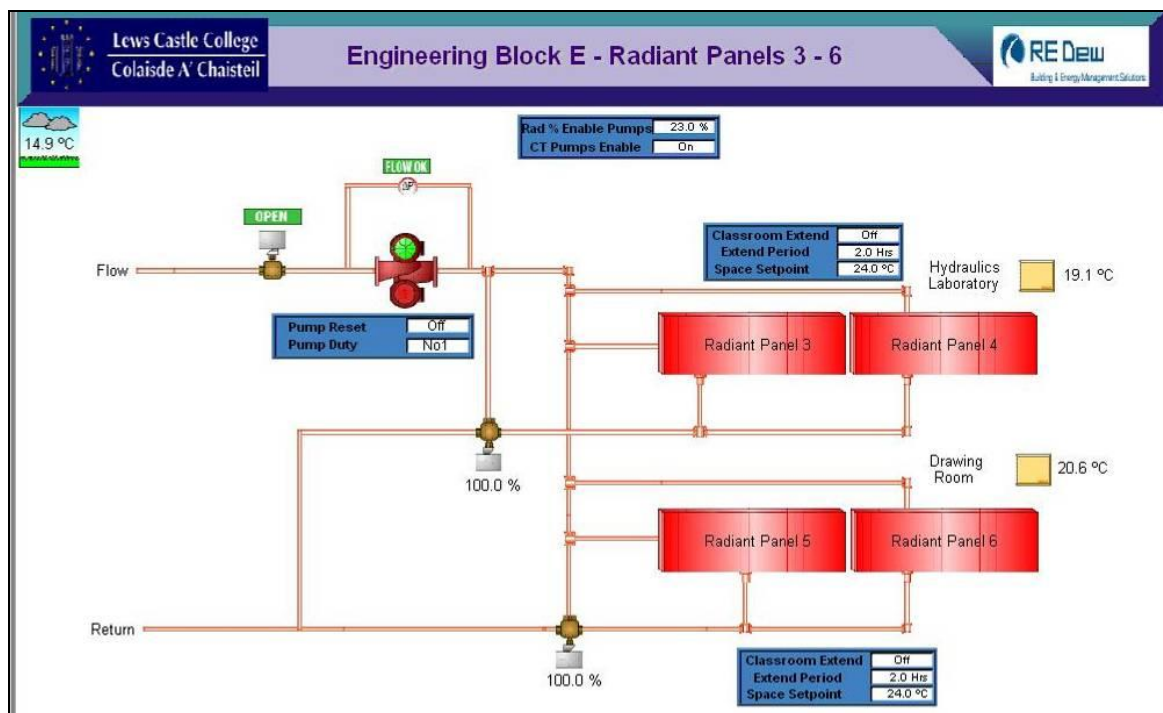
Figure E-9: Engineering Building heating circuit 2

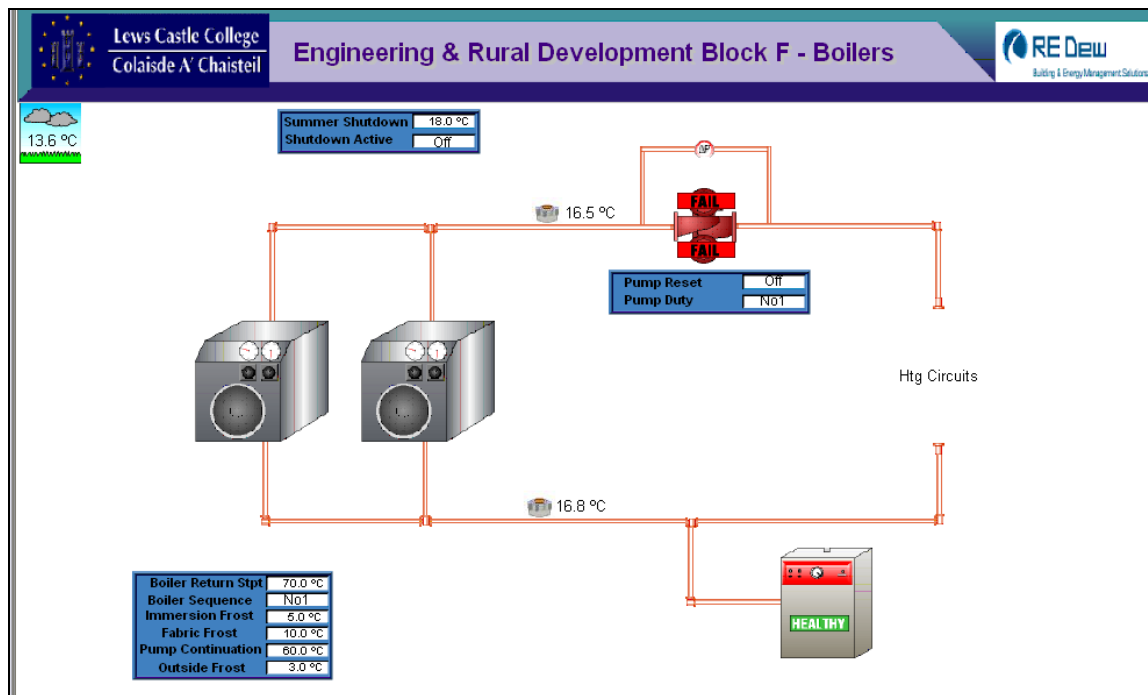
Figure E-10: Rural Building boiler room

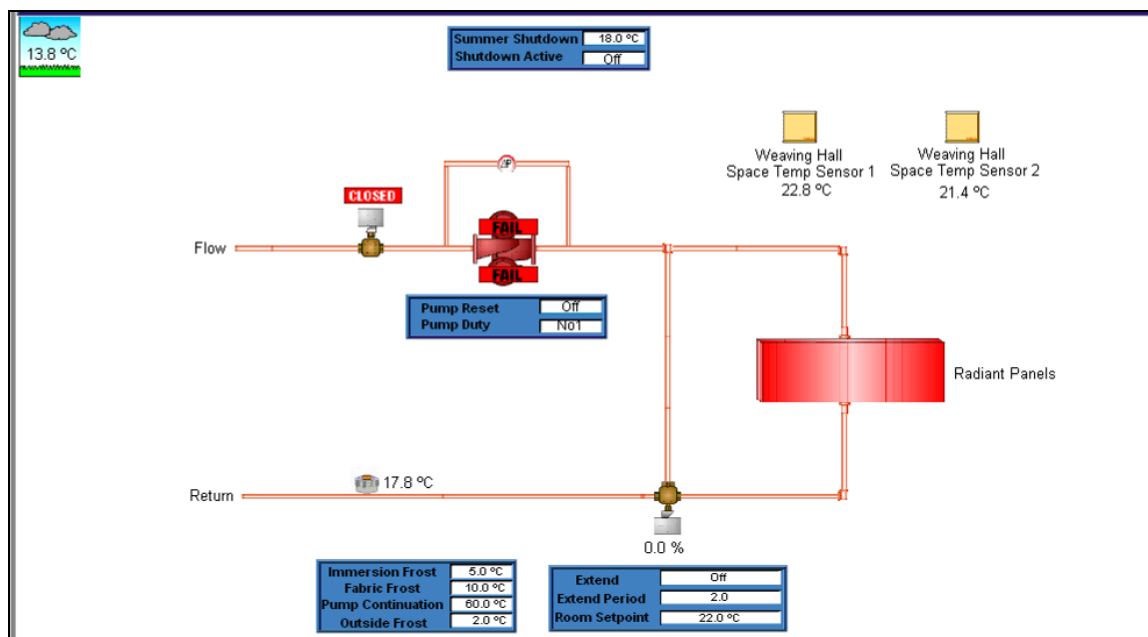
Figure E-11: Rural Building heating circuit
