Domestic Hot Water Efficiency and Losses

Sponsor: Orkney Islands Council

A thesis submitted in partial fulfilment for the requirement of the degree

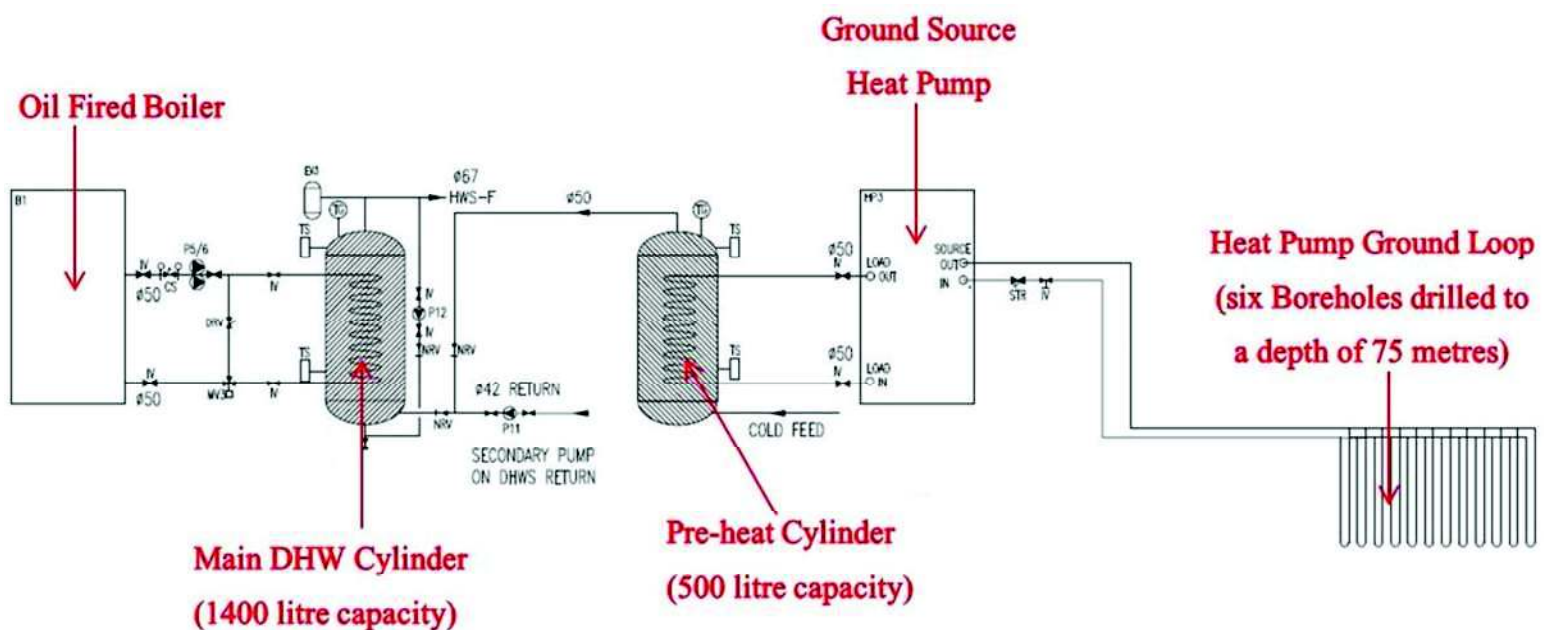
The current system incorporates an IVT Greenline D40 geothermal heat pump which is connected to a 500 litre pre-heat accumulator tank. The pre-heat tank feeds the main domestic hot water cylinder, a 1400 litre indirect copper calorifier, complete with destratification pump. A Clyde CK10-87/6 oil boiler, complete with Riello 40 G20D burner, provides supplementary heat to the main DHW cylinder. The oil boiler uses Class D oil (gas oil). In domestic settings the heat pump Rego 600 control unit would regulate the boiler operation, only activating it when the heat pump called for additional heat. However, the system at the care home is too complex to be controlled in this manner; therefore a BMS system monitors the temperatures in both accumulator tanks and controls the operation of the oil boiler. Additionally, DHW is provided through calorifiers (capacity of 360 litres) in each wing (with the exception of wing A as the plant room is situated there). The secondary circulating pump is mounted in the pipework and has a flow rate equal to 1.5 litres per second. The main components are illustrated in Figure 3-1.

Figure 3-1: DHW System

The boreholes of the geothermal heat pump reach a depth of 75 metres where the temperature remains constant at 13°C (Energy Efficiency Best Practice in Housing, 2004). The heat pump has a COP equal to 3.2 (IVT Heat Pumps, 2003).

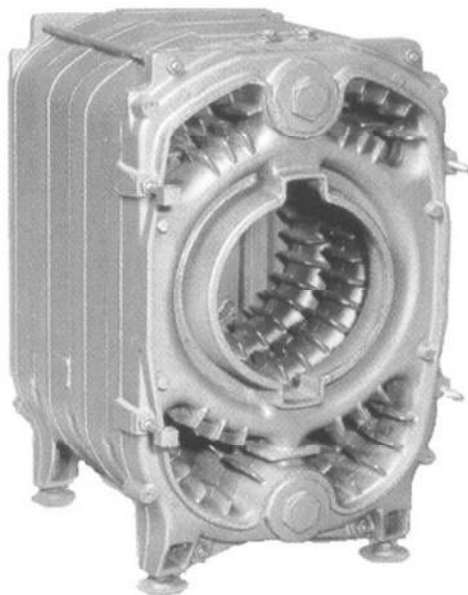
Figure 3-3: Boiler Internal Structure

The Clyde CK10 boiler is made up of six sections and has a seasonal efficiency calculated at 84%. It has a maximum working pressure of 8 Bar and a maximum operating temperature of 110°C. The thermal efficiency (heat to water (NCV)) is equal to 88.76%. Water flow rates range from 0.63 to 1.73 litres per second, depending on the temperature rise in the water.

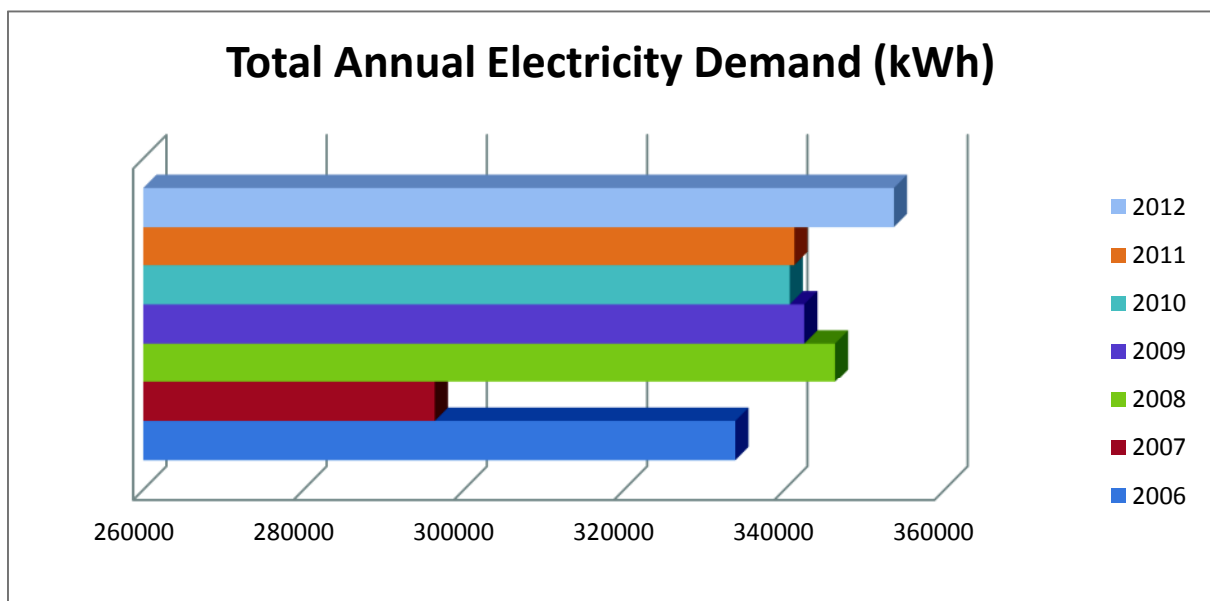
Figure 4-11: Total Annual Electricity Demand (kWh)

As in Figure 4-10, Figure 4-11 illustrates a significant decrease in demand between 2006 and 2007 (greater than 11%). Between the years 2007 to 2012 the increase in demand ranged from 6800 kWh to 19800 kWh over the 2007 value. However, the total annual demand exhibited a different pattern to the seasonal equivalent, therefore Table 4-2 has been provided to illustrate the differences observed between the annual and seasonal demand.

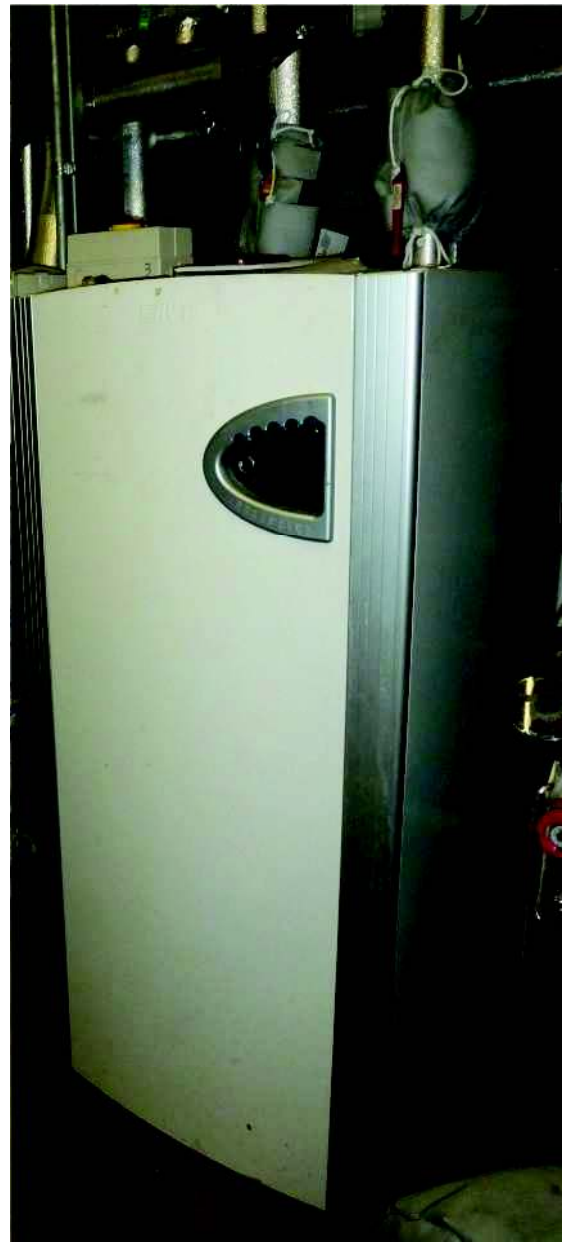
Heat pump hours of operation, set point temperature, return thermostat stop temperature (maximum operating temperature), current temperature of the pre-heat cylinder, as well as the maximum allowed hysteresis (this value determines how far the temperature can fall below the set point before the heat pump is engaged to raise the temperature to the set value again.)

Figure 5-1: DHW Heat Pump (HP 3)

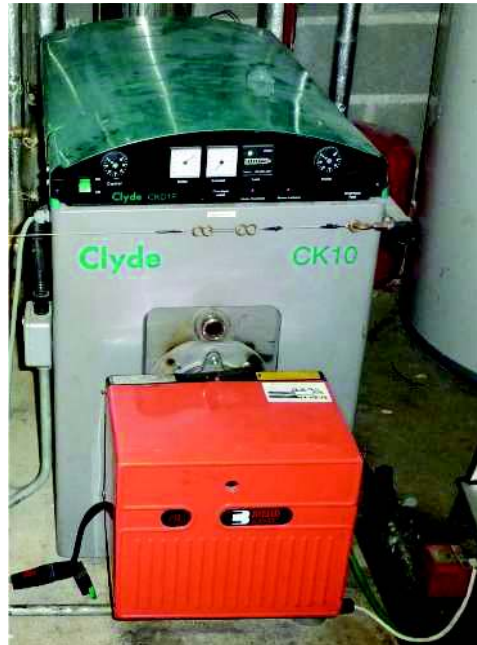
Figure 5-2: DHW Oil Boiler

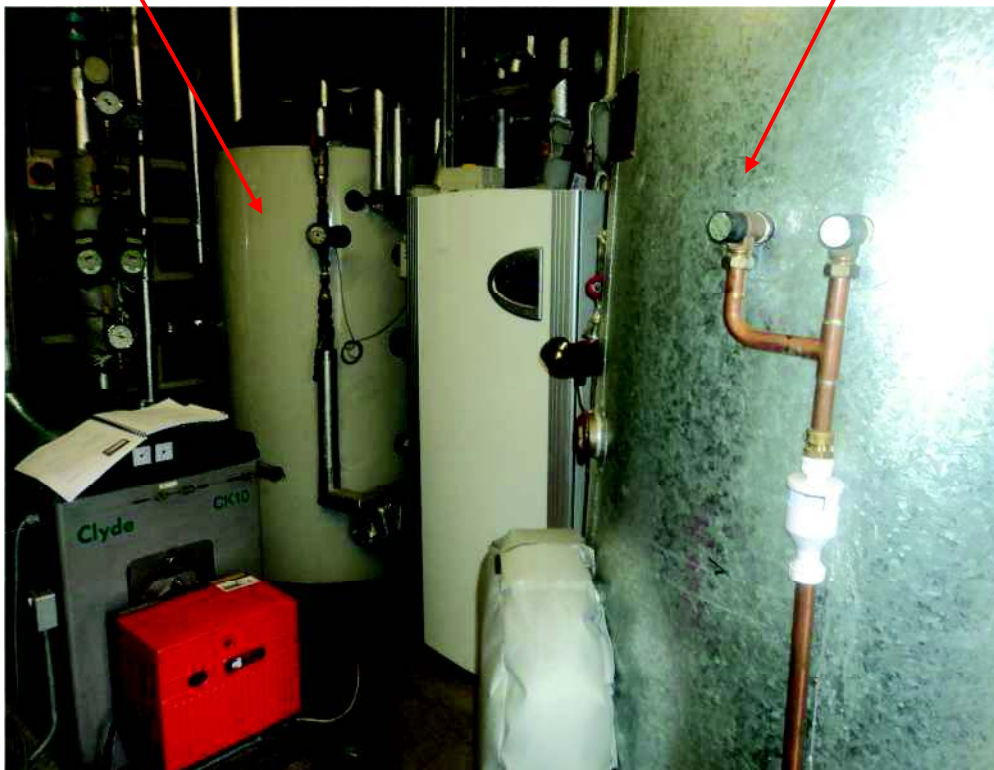
Pre-heat Cylinder

Main DHW Cylinder

Figure 5-3: Accumulator Tanks

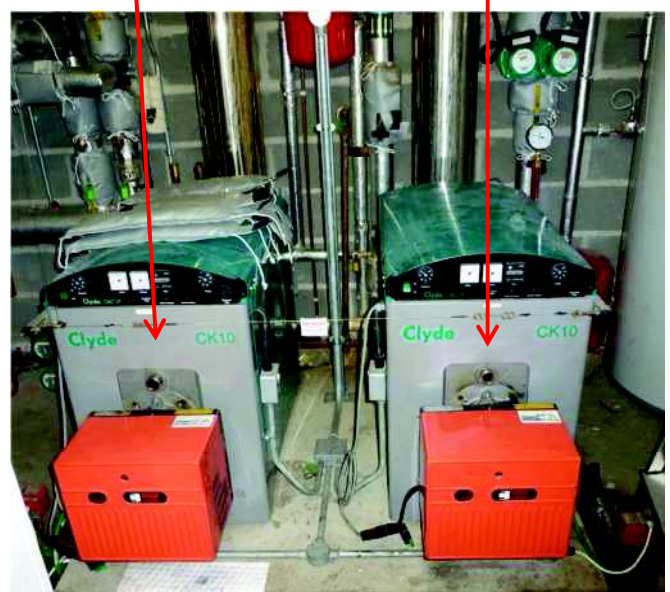
Under floor heating Oil Boiler and Burner

DHW Oil Boiler and Burner

Figure 6-3: Oil Boilers

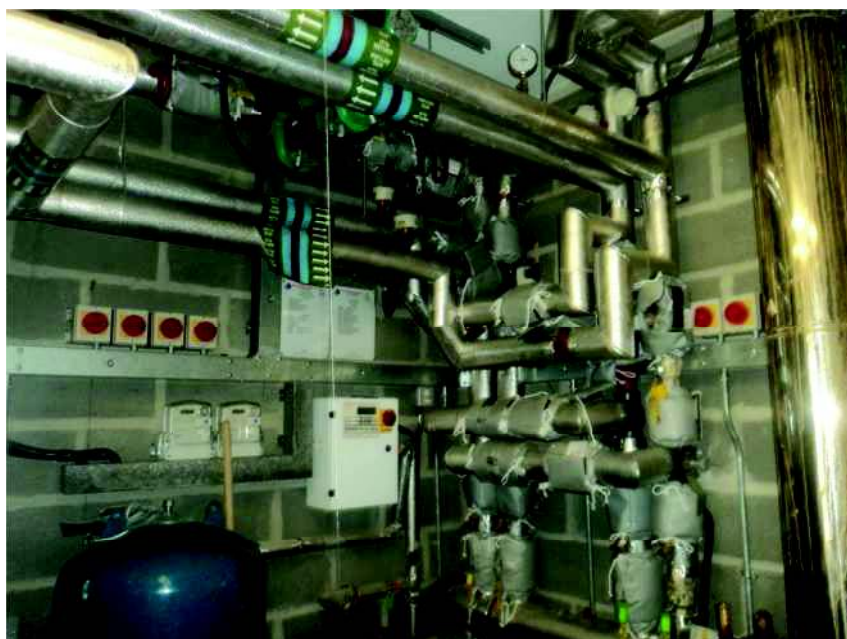
Figure 6-5: Pipework Modifications

Some of the pipework in the plant room had been redesigned (notice the double rows of pipes), however this occurred in the under floor heating system and does not directly affect the DHW system; therefore it is out with the scope of this project. However it could indicate that there have been similar errors made in the design or installation of the DHW system.

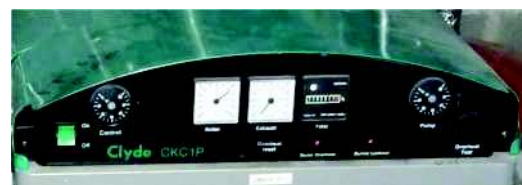
- Boiler Thermostat = 84°C
- Total Hours of Operation = 17009:86
- Exhaust Gas Temperature = 25°C
- Pump Overrun Temperature = 75°C

Figure 6-10: Oil Boiler Control Panel

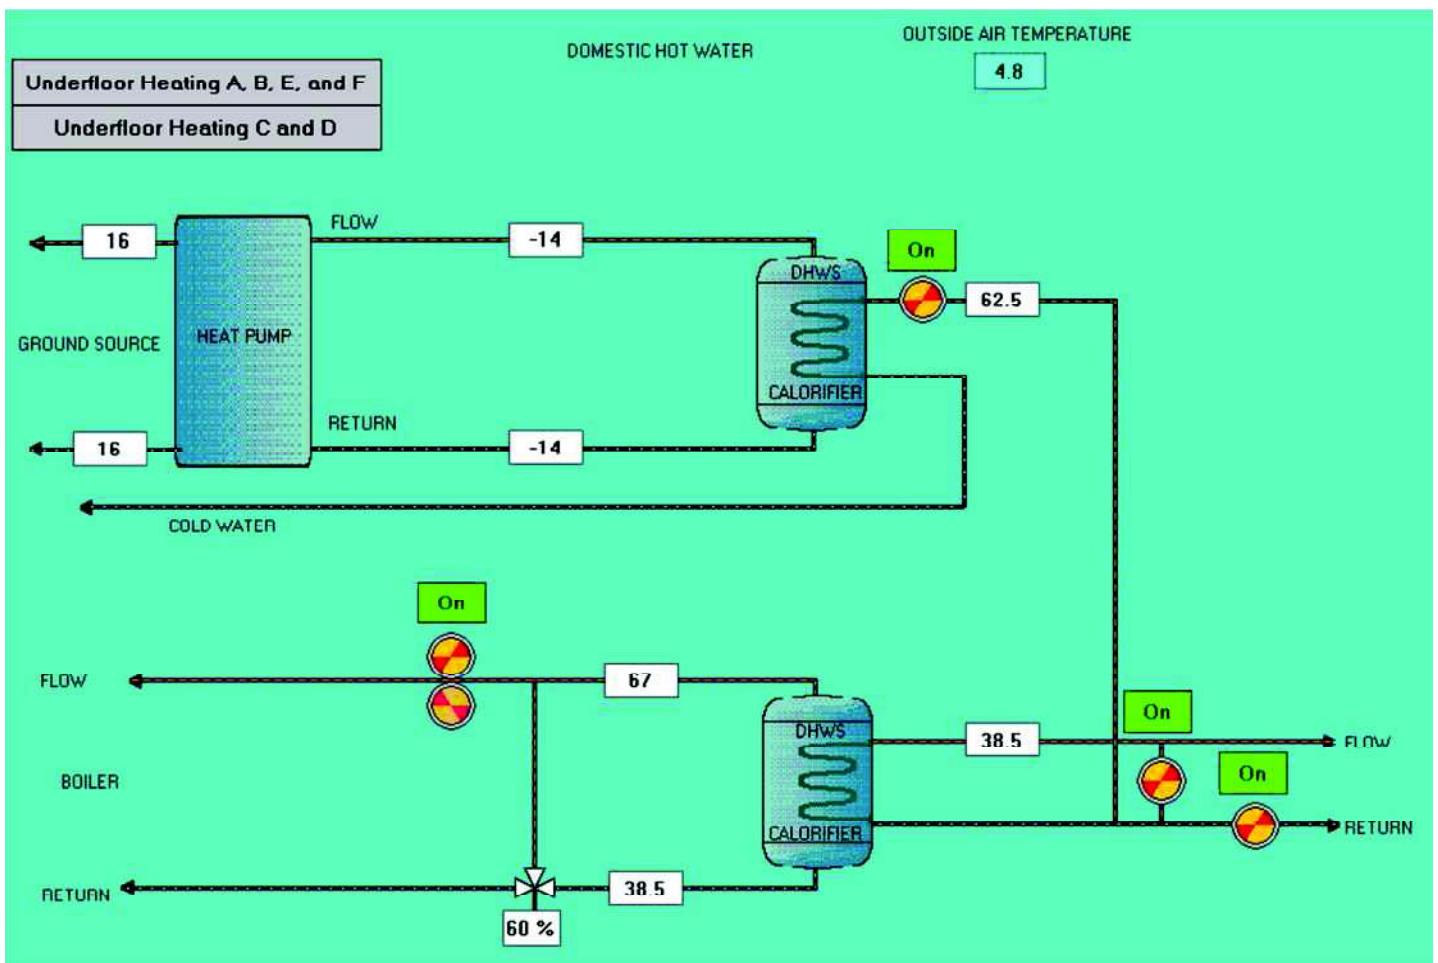
The following figure, obtained from the on-site computer, which monitors the boiler house and domestic hot water system, provided further evidence that the oil boiler was responding to the sensor in the pre-heat cylinder, as opposed to the main DHW cylinder.

Figure 6-12: Evidence of Sensor Error

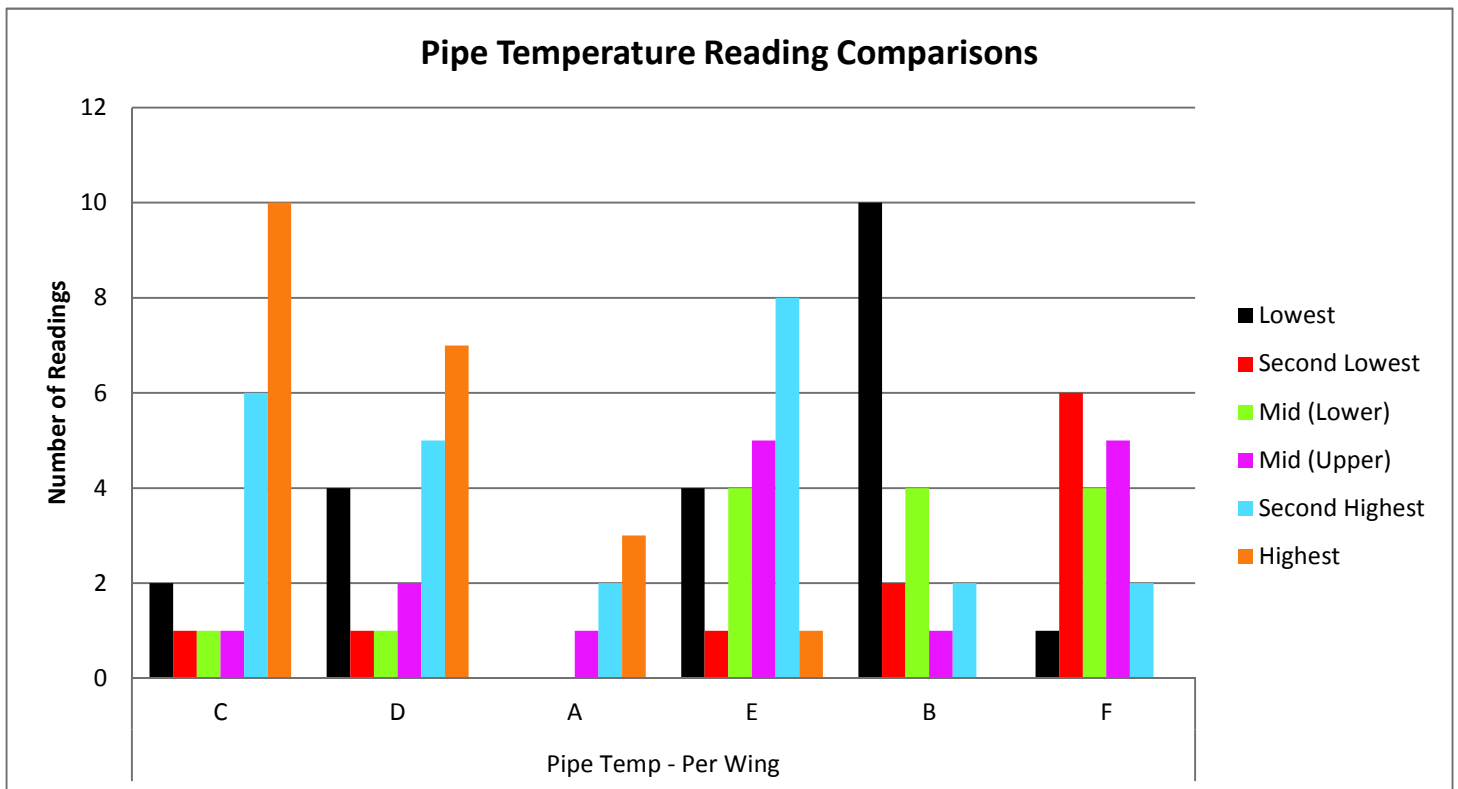
Additionally, water should be discharged between 35°C and 46°C, as per the UK Health and Safety Executive recommendations; which ensure good sanitary conditions whilst minimising the risk of scalding (although there is some variation in the temperatures recommended for use with “at risk” groups compared to those in kitchen areas, etcetera). The discharge temperatures recorded in the care home ranged from 38.2°C to 45.4°C and therefore met this requirement.

Figure 7-3: Pipe Temperature Per Wing
