The Study of Corrosion and the Investigation of Peat Contamination in Steel

A thesis submitted in partial fulfilment for the requirement of the degree

Master of Science

2015

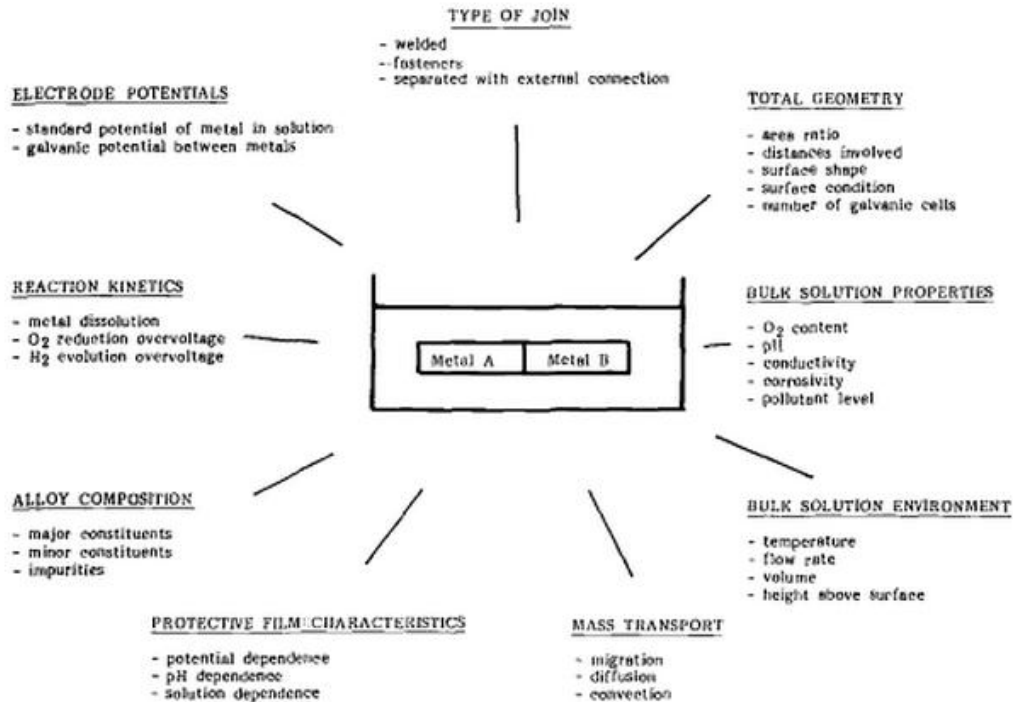
Figure 2 Factors involved in galvanic corrosion (Oldfield 1988)

Of the many different types of corrosion problems experienced in the energy industry, corrosion arising from the interaction between different metals and alloys is one of the most troublesome and complex, this type of issue is commonly referred to as Galvanic Corrosion (also known as Bimetallic Corrosion). Galvanic corrosion occurs when a metallic material is in electrical contact with another metallic material or conducting non metal in the same electrolyte causing a galvanic current to flow between them. M.Finsgar (2013). The potential difference that exists between the two metal encourages the corrosion, where the more noble material acting as a cathode (negatively charged electrode) will remain unchanged whereas the more active metal acting as the anode (positively charged electrode) will corrode. (Oldfield 1988). A large number of factors in addition to the potential difference between the dissimilar metals play a role in the galvanic corrosion process. Depending on the situation some or all of the factors illustrated below in Figure 2 may be involved.

The feature of electrode potential in galvanic corrosion is that the standard potential of a metal in a solution of its ions highlights where the approximately the metal is in the galvanic series - discussed further later on. However the electrode potential is often very different between the core metal and the surface oxide film as such in practice it is the oxide that locates the material in the galvanic series (Oldfield 1988) and (Zhang, 2011).

The reaction kinetics are significant factors in determining how quickly the rate of corrosion can occur. The corrosion potential of the metal is typically between the equilibrium potential of the anodic metal dissolution and the cathodic oxidant reduction. The rate of the anodic reaction is given from the metal dissolution kinetics, whereas the rate cathodic reaction provided from the oxygen reduction on the metal/alloys concerned (Oldfield 1988).

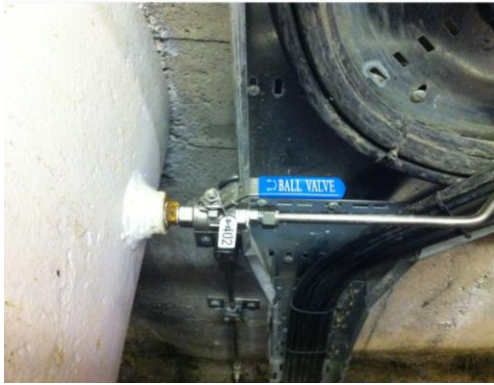
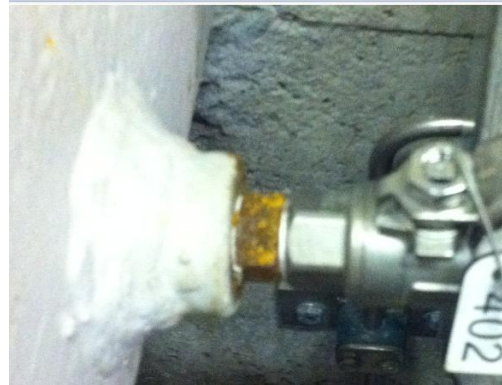
Figure 4 Galvanic Corrosion - Example 1

Shown below in Figure 4 is an example of a recent pipework installation at a refurbished power station in the West of Scotland. To monitor pressure levels in the penstock, stainless steel 316L pipework and fittings have been fitted directly into the mild steel penstock pipe. The installation is only a matter of months old and looking at the image below you can see the early stages of what appears to be galvanic corrosion.

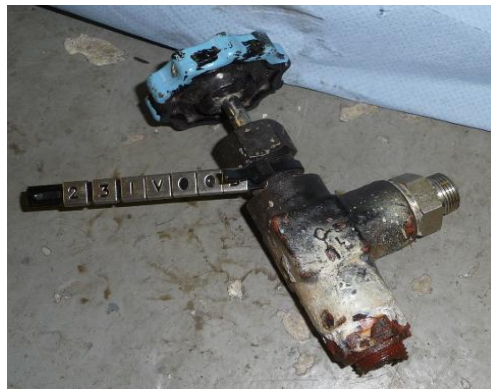
Figure 5 Galvanic Corrosion - Example 2

A further example of the problems associated with galvanic corrosion is revealed below in Figure 5. Shown are the threads of a carbon steel valve that was screwed into a stainless steel boss on the spiral casing - spiral shaped pipe. As you can see the threads have almost totally been eaten away and were very close to failure.

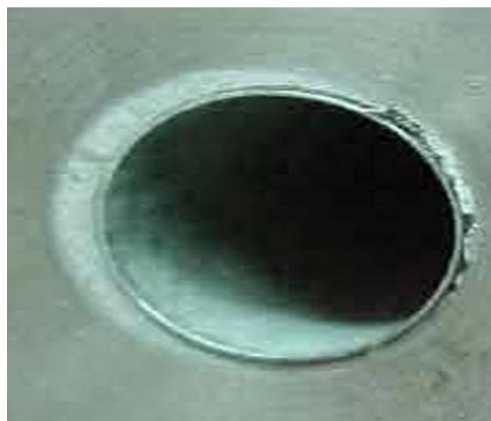
Figure 6 Crevice Corrosion Example 1

Two images of crevice corrosion are shown below in Figure 6 and 7. The first example shows the occurrence of crevice corrosion as a result of the gap between the type 316 stainless steel tube and tube sheet in a seawater reverse osmosis desalination plant. The second example illustrates a full brown crevice in an otherwise highly resistant to seawater material.

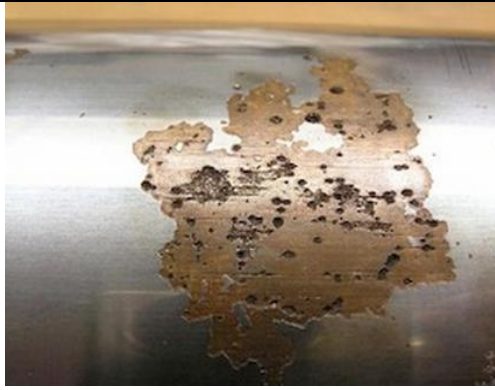
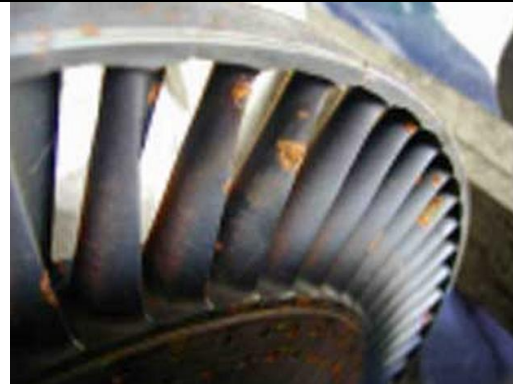
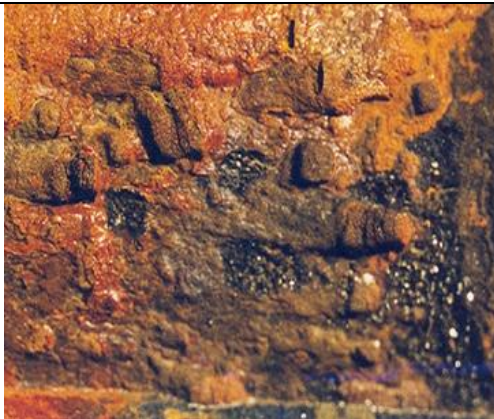
Some commonly seen examples of pitting corrosion are shown in the Figures 9 to 12 underneath. The first image (Figure 9) is of pitting corrosion in the bronze layer underneath chromium plating which has been removed. The second picture (Figure 10) shows corrosion pitting taking place on the blades of a steam turbine. Figures 11 and 12 show CO₂ and H₂S pitting respectively. Pitting in the CO₂ environment produces pits that are generally small with sharp edges and smooth rounded bottoms whereas in the sour H₂S system the pitting observed are more shallow round depressions with etched bottoms and sloping sides.

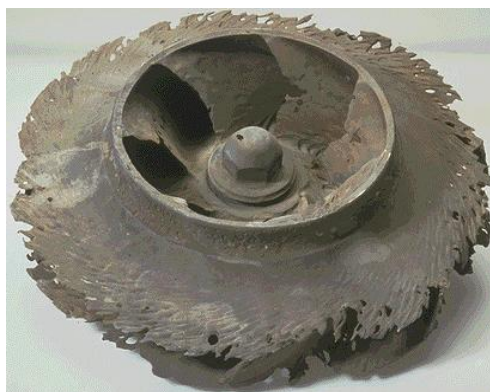
Figure 13 Erosion-Corrosion Example 1

The first erosion-corrosion example shown in Figure 13 is a bronze impeller from a centrifugal pump. The impeller was used in a chemicals transportation system and on studying the surface you can see the impeller has been attacked with a distinct flow pattern

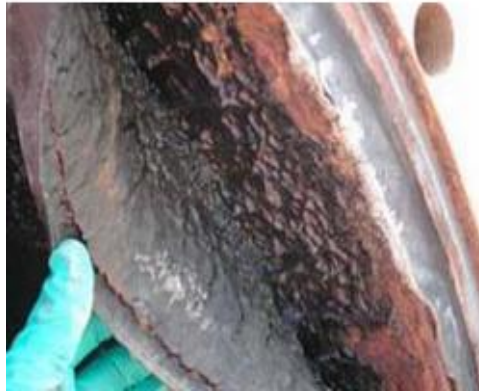
Figure 14 Erosion-Corrosion Example 2

Shown in Figure 14, is the image of a carbon steel pipe used for transporting slurry at a mine. Looking at the picture the protective rubber lining has become delaminated which has led to the rapid onset of erosion-corrosion in the underlying steel pipeline.

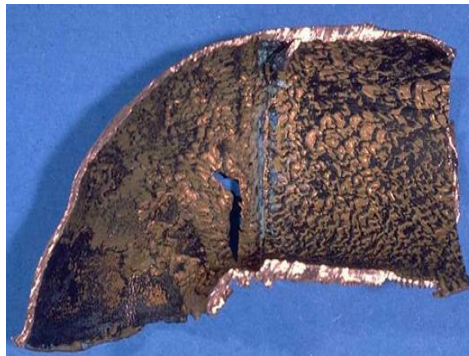
Figure 15 Erosion-Corrosion Example 3

The final example of erosion-corrosion damage (Figure 15) is in a copper pipeline, where water swept pits similar to small horseshoe shaped features are present.

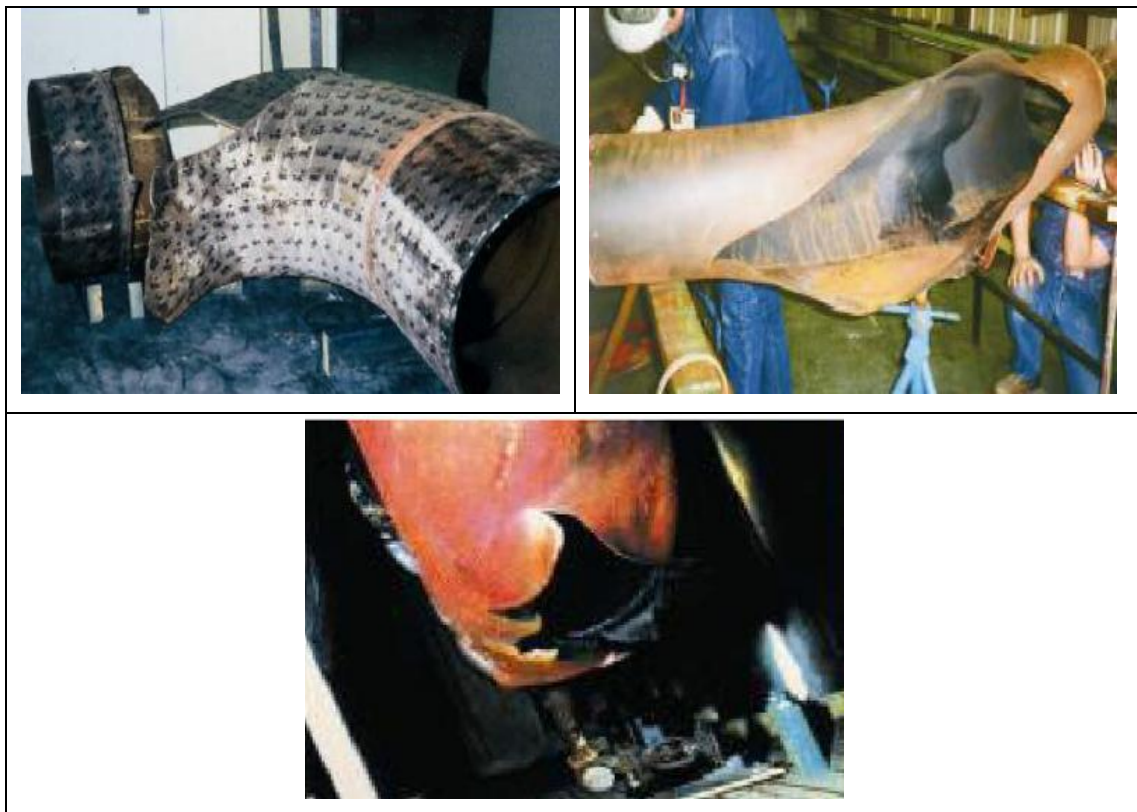
Figure 16 Examples of Flow Assisted Corrosion - (Ahmed, 2010)

Below is a sample of the problems that have been witnessed at numerous ageing power generation stations throughout the world. Image one (Figure 16 - top left image), shows the wall thickness of an 18" elbows that has decreased from 12.7mm to 1.5mm due to flow assisted corrosion. The second image (Figure 16 - top right image) is of an actual failure that occurred in a high pressure extraction line at Fort Calhoun nuclear power station in 1997. The final image (Figure 16 - bottom centre image) is also from a nuclear power station - Millstone Unit 2 - and shows the pipeline rupture at an 8 inch elbow of a moisture separator reheater in 1991. The flow assisted corrosion was not picked up due to the lack of condition monitoring such as ultrasonic thickness checks being missed on that section of pipe from the routine maintenance checks.

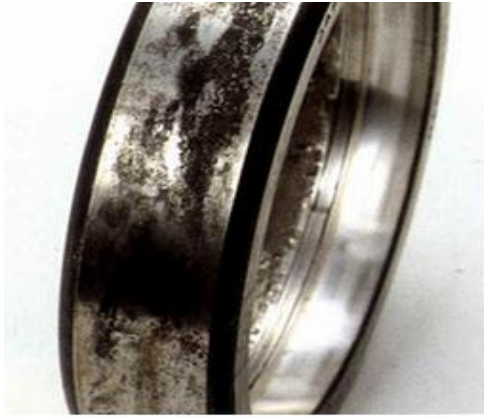
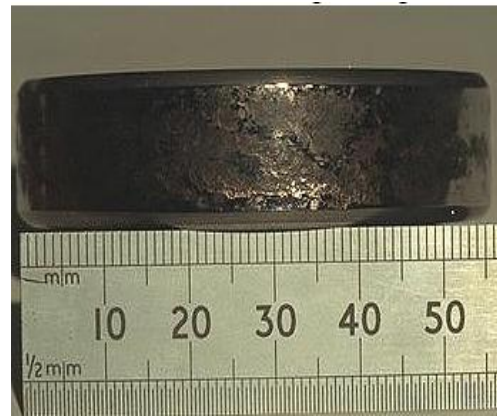
Figure 17 Fretting Corrosion Example 1 Figure 18 Fretting Corrosion Example 2

Figure 17 shows an example of fretting corrosion on the outer diameter of a spherical roller. The cause of the fretting was a result of micro movement between the bearing and mating housing bore. More extensive corrosion is shown in Figure 18 on the outer race of a deep groove ball bearing.

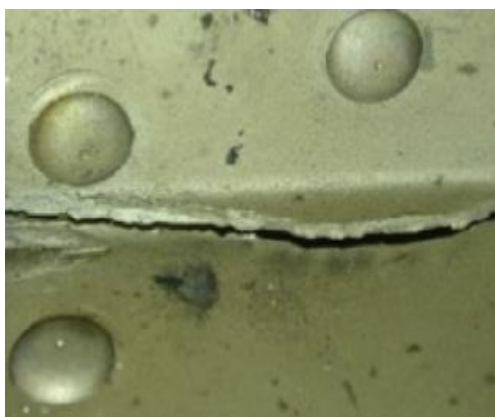
The example shown in Figure 20, is of a stress corrosion crack in an aluminium alloy used in an aircraft structure. The photomicrograph shown Figure 21 is of a crack initiation from the pit at the weld fusion line and its localised propagation in a tree root shape.

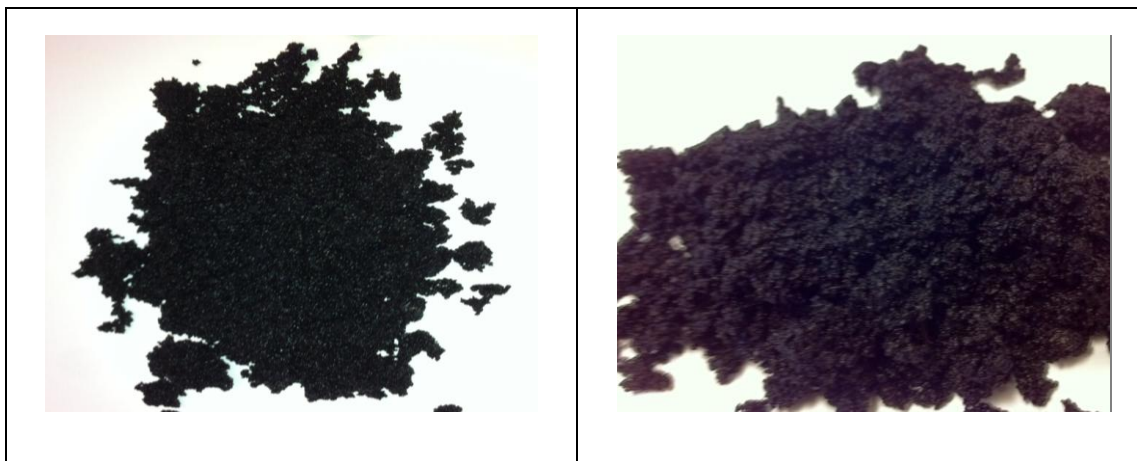
Figure 24 Peat Sample

Peat can be defined as the partially decomposed remains of plants and soil organisms which have accumulated in a water saturated environment in the absence of oxygen. Its primary uses is as a fuel source and a fertiliser. The build up of peat is increased when the new organic material on the surface surpasses the rate of decomposition and 'turn-over' of the surface material. Typically in the UK this occurs seasonally or year round due to the UK climate being wet and cold. The Scottish National Heritage (SNH Report) refer to peat as being far less dense than other soil materials, and it having the majority of its volume taken up by water when wet. The typical carbon content of peat found in the UK is approximately 52% by dry weight, further to this, the ratio of organic matter in peat is very high, typical percentages found are above 20-25% for 'peaty' soil and more than 50-60% organic matter for 'peat' (SNH Report). Peat has been portrayed as having some very unique characteristics for instance it acts as a water repellent barrier when very dry. These features of peat are as a result of the variety of organic compounds that are formed during the decomposition of living organisms. A photograph of the peat used during the testing phase of the project is shown below in Figure 24. The peat sample was taken from the inside surface of the main tunnel pipe at a hydro power station after the pipeline had been dewatered.

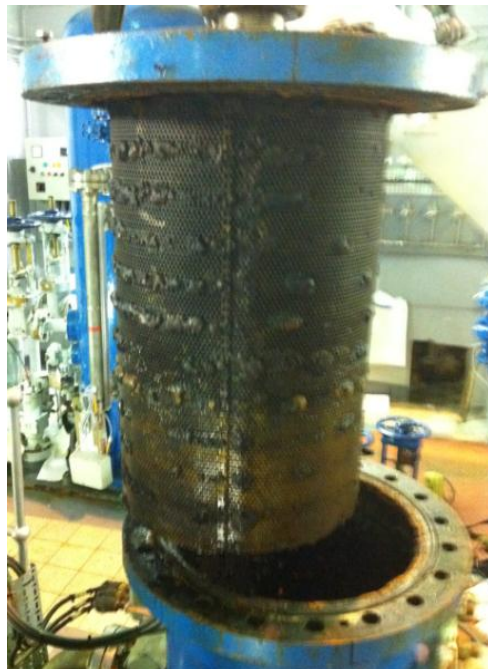
Figure 27 MIV Control Water Rotary Filter

To try and glean an understanding of the problems of peat contamination within hydro power stations across Scotland several site visits and discussions with local engineers were undertaken. However due to operational demands it proved difficult at times to get an intrusive inspection of the pipework systems. Fortunately, during one site visit planned routine maintenance was being performed by the local staff and the opportunity to witness the issues of peat contamination first hand was presented. As shown below in Figure 27 you can see pockets of peat sticking to the mesh of a control water rotary filter for the Main Inlet Valve (MIV) – a valve used as a safety device located upstream of the turbine within the power station building - the role of the rotary filter is to provide clean control water to the water operated actuator that is used to stroke the MIV. The MIV actuator requires reliable, stable and controllable supply to allow it to operate the valve appropriately, therefore any constraints to the flow can be a major problem. From speaking with the local staff this is a common issue and they regularly have to pressure wash the filter basket to remove the peat deposits.

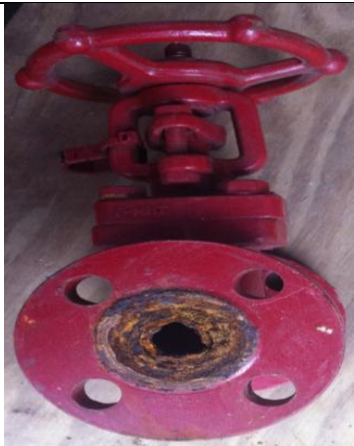
Figure 28 Cooling Water Isolating Valve

the problems he had with maintaining the required cooling water flow – to keep the bearing oil temperatures within their operating parameter - to the rotor shaft bearings as peat would over time choke sections of the pipework and valves that made up the system. Shown below in Figures 28 to 31 are a selection of the cooling water system photos that were taken throughout the day. Looking at them you can see clear evidence of peat build up which will restrict the flow. It is not entirely clear why the peat sticks to the carbon steel material but it can usually be removed from the cooling system by increasing the system water pressure, however this has an operational problem once the flows to the bearings are altered. A further problem that was discussed with the hydro engineer was to do with the cooling water flow control relay shown in Figure 29. The problem being the peat contamination prevents the intrusive disk in the flow from changing over the electric switch accurately therefore the software in the control room of the power station could be showing healthy or unhealthy flow when it is actually the opposite.

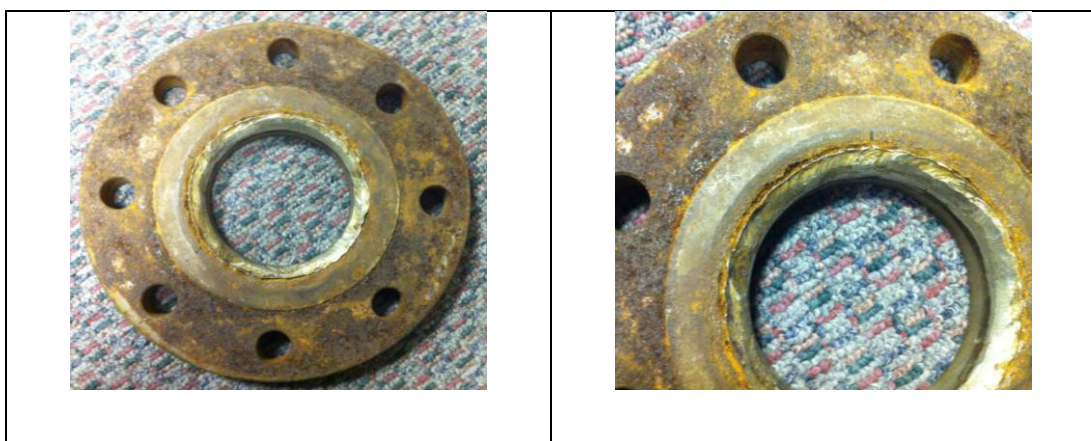
Figure 32 Flange from Power Station Visit – Galvanic Corrosion

Furthermore on further inspection at a different power station the flange shown in Figure 32 was found. Although no longer in service, conversation with the hydro engineer on site provided some interesting information on its history. The flange material is carbon steel and it has been welded onto the stainless steel pipework in the past. This method was attempted in the late 1980's to try and tackle the issue of galvanic corrosion whilst minimising the cost implications as it prevented the need to supply expensive stainless steel flanges that were suitably pressure rated. Although the weld was undertaken using dissimilar metal rods, you can see clear evidence of material wear due to galvanic corrosion along the weld. Looking at the image it is clear to see why this method is no longer standard in the hydro industry.

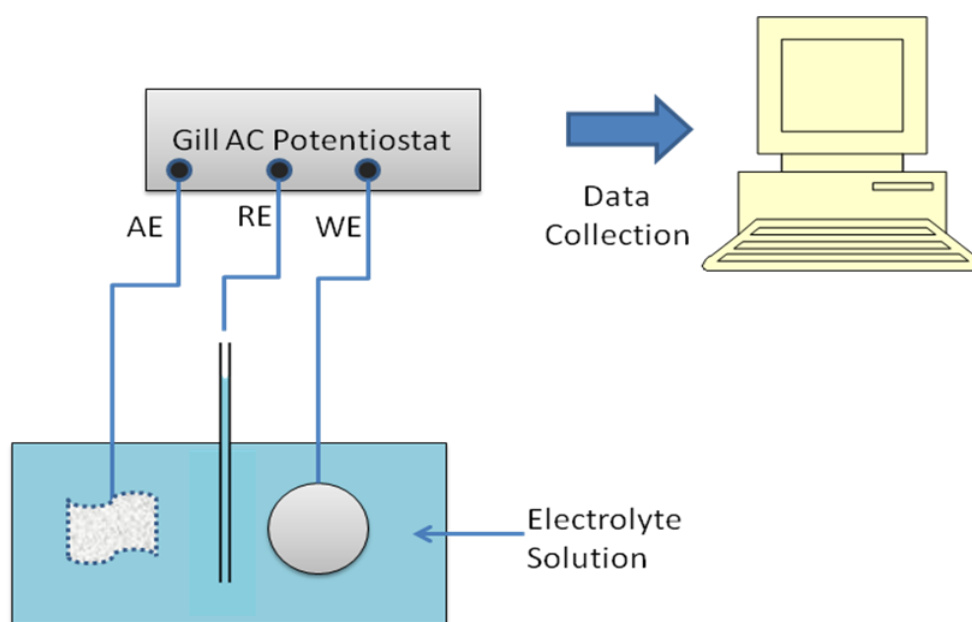
Figure 33 Test Set-up

The electrochemical tests were conducted in a corrosion cell with three-electrode system using a Gill AC electrochemical potentiostat (ACM instrument, UK), as shown below in Figure 33. The potentiostat was linked to the Core Running/Sequencer software located on a nearby computer which allowed for the polarisation curves to be produced. To ensure a stable and reproducible potential in the solution the working electrode (WE) was measured against the reference electrode (RE) by the means of a voltmeter. A saturated calomel electrode (SCE) was used as the reference electrode which consisted of mercury covered with a paste of mercurous chloride and mercury in a chloride solution. The Auxiliary Electrode (AE) was of a Platinised-Titanium (Pt-Ti) mesh formation.
