# **Confirming the effectiveness of insulation upgrades applied to Glasgow housing**

## **Final report to Glasgow City Council**

Allison J, Cameron G, Clarke J A, Cockroft J,  
Markopoulos A and Samuel A  
Energy Systems Research Unit  
University of Strathclyde

24 August 2015

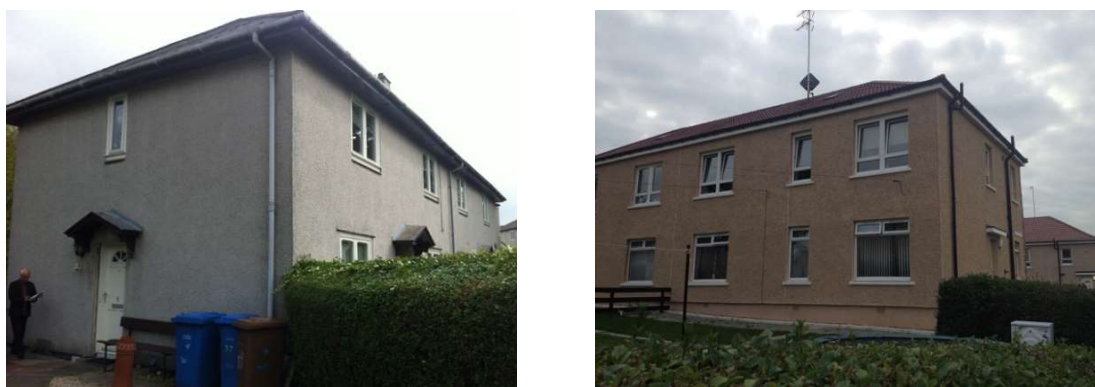
Generally, 100 mm external wall insulation was applied and houses already had loft insulation. In Mossspark, internally and externally applied insulation approaches were compared. Figure 2 depicts typical examples of dwellings before and after insulation upgrade.

Figure 2: A typical uninsulated property in Carntyne (left) and an externally insulated property in Shettleston (right).

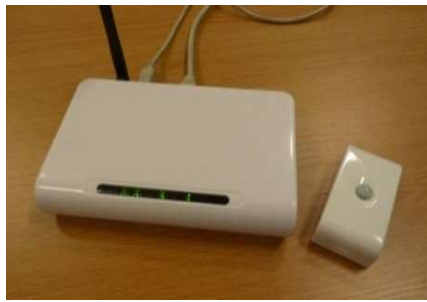
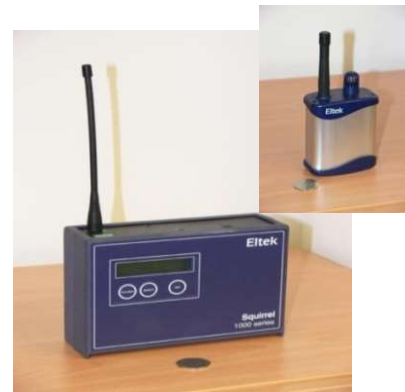
The equipment required to monitor indoor conditions comprises two combined temperature and humidity sensors located within each dwelling, each with a built-in low power radio transmitter. A single radio receiver associated with each group of dwellings collects data from each sensor at 5-minute frequency. The receiver records the readings and these are then downloaded periodically. Sensors within properties have to be positioned in such a manner as to obtain a reasonable measure of temperature and humidity, but at the same time be unobtrusive to occupants and not susceptible to interference. For properties located far from the receiver, it is necessary to install longer antennae, and to position sensors at elevated positions within rooms. To provide consistent measurements of room conditions, it is also necessary to ensure that each sensor is not moved significantly away from its location during the monitoring period, particularly if a property is insulated during that period. Small adjustments may be made to sensor readings to simulate a centre-of-room positioning. In each dwelling, one sensor is installed in a living or bedroom area, and a second sensor is installed in a kitchen or bathroom depending on where high humidity levels are likely to be experienced.

Figure 3: BuildAX receiver/sensor (left) and Eltek receiver/sensor (right).

Figure 3 shows the sensor/transmitter and receiver equipment deployed, while Figure 4 depicts a typical installation – the sensors are highlighted with red arrows; as can be seen, the visual impact for the occupant is minimal. This scheme generates the information required to subsequently calibrate the dwelling models, and requires minimum interaction with the resident.

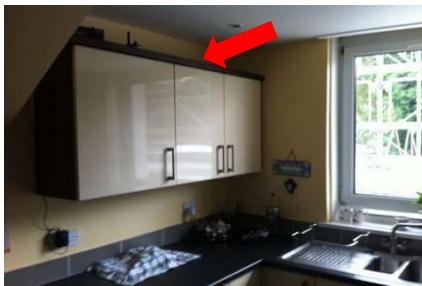
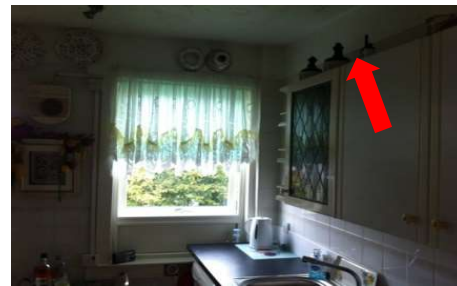
Figure 4: A typical monitoring installation.

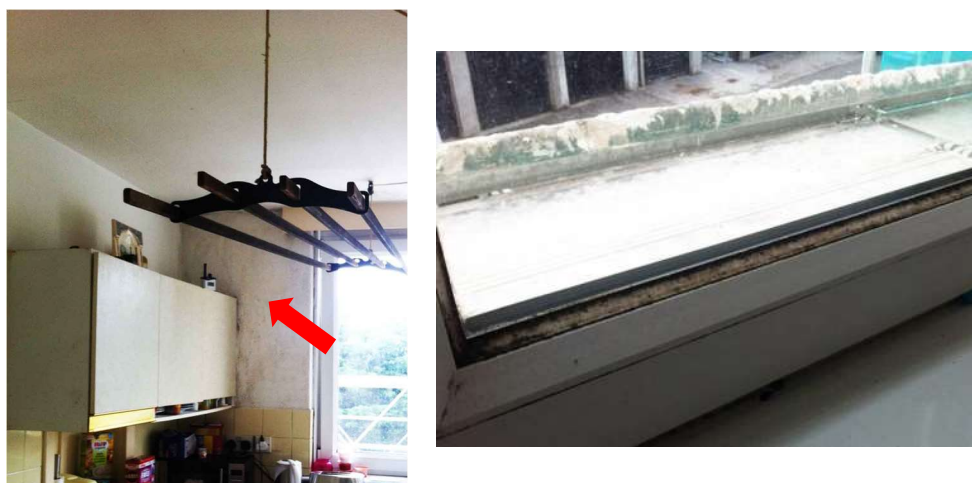
One property (SB2) exhibits severe mould growth problems on the inside surface of the outer walls (Figure 7).

Figure 7: Occurrence of a severe mould growth problem.

Closer inspection revealed that mould has formed on the double glazed window seal, suggesting that condensation has been forming on the inner pane of the window. This suggests that the problem is condensation, not a building fault. The property is occupied by a family with four children, a higher occupancy level than other properties in the group. The recorded data shows particularly high humidity levels regularly exceeding 80% RH. While the insulation applied to this property reduced the condensation problem on the walls, further inspection would be required to detect if any residual cold bridges have been created during the insulation process as this could become a problematic source of hidden dampness. In any case, this is a site where advice should be given to the occupant concerning the need for additional ventilation (window opening) when cooking, bathing and indoor clothes drying.

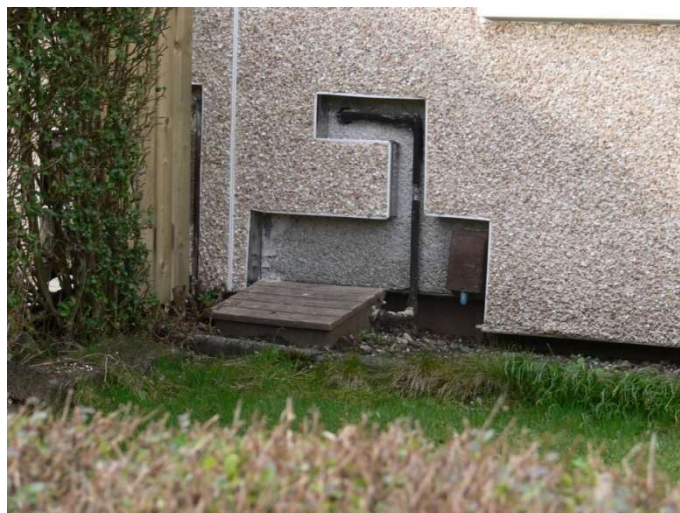
An example of a cold bridge is shown in Figure 8, where insulation has been omitted around a gas meter and pipework.

Figure 8: thermal bridge due to non-insulated section around a gas pipe and meter box.

Consideration should be given to careful internal inspection after a period of time to identify the incidence of dampness problems caused by such omissions and remedial action should be taken where necessary. Examples include the exceptional observations of Table 3 (note that individual dwellings may fit into more than one category).
