Department of Mechanical and Aerospace Engineering

Wind Turbine Decommissioning: Mechanical Assessment of Yaw Calipers for Reuse.

A thesis submitted in partial fulfilment for the requirement of degree in
Master of Science in Sustainable Engineering: Renewable Energy Systems and the
Environment

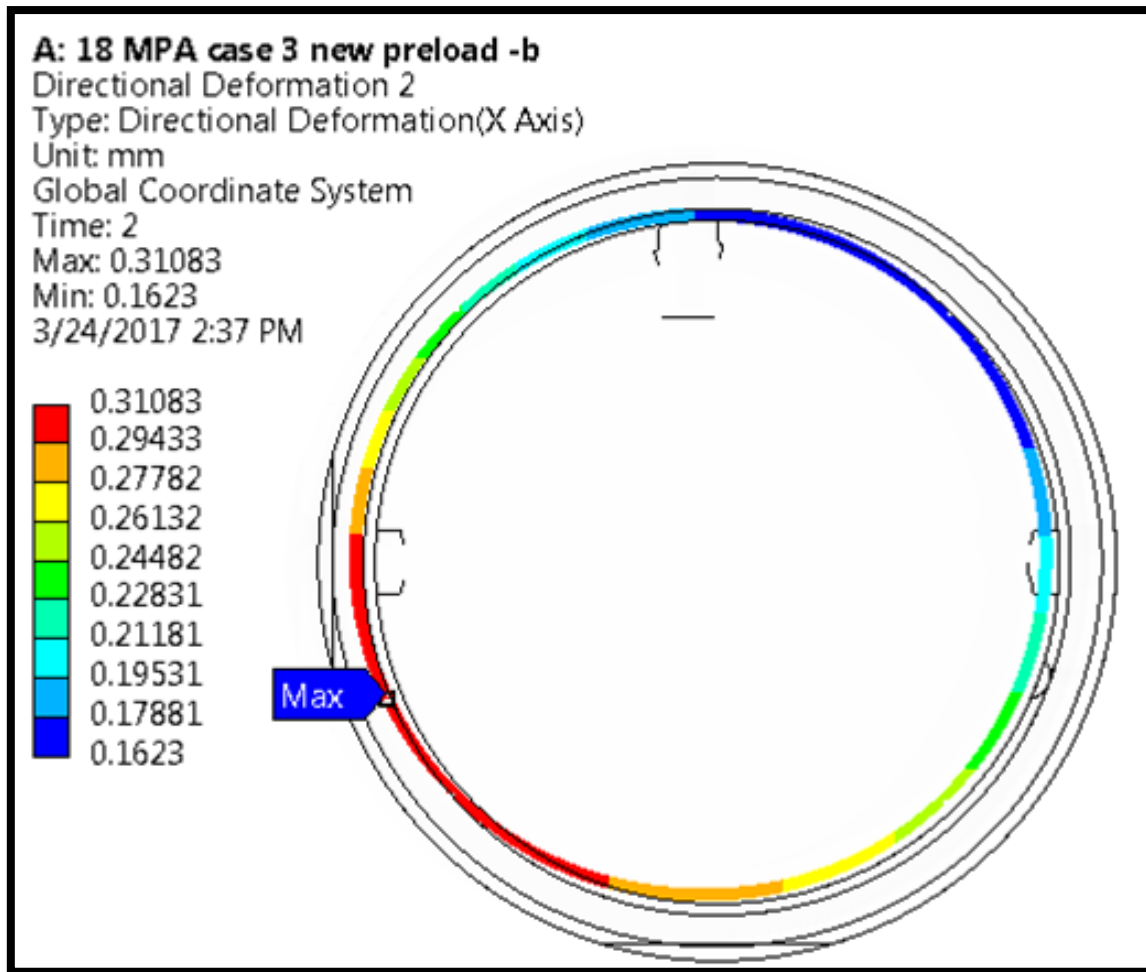
Piston cylinder damage can lead to the undistributed pressure in pistons and therefore will lead to a reduction in efficiency. Over time if this was to worsen then a failure could occur. Typically, form damage of the cylinder is only seen on one of the pistons in a caliper half. This can also lead to unsymmetrical damage of seals leading to their failure which in turn increases Operation and Maintenance (O&M) costs. Figure 6 highlights in yellow the start of damage to the piston cylinder. FEA analysis conducted by Siemens on the structural properties of the component under operational conditions show that the cylinders would experience this type of damage through its lifetime, see Figure 7.

Figure 7: Siemens FEA of Piston Cylinder Deformation [4]

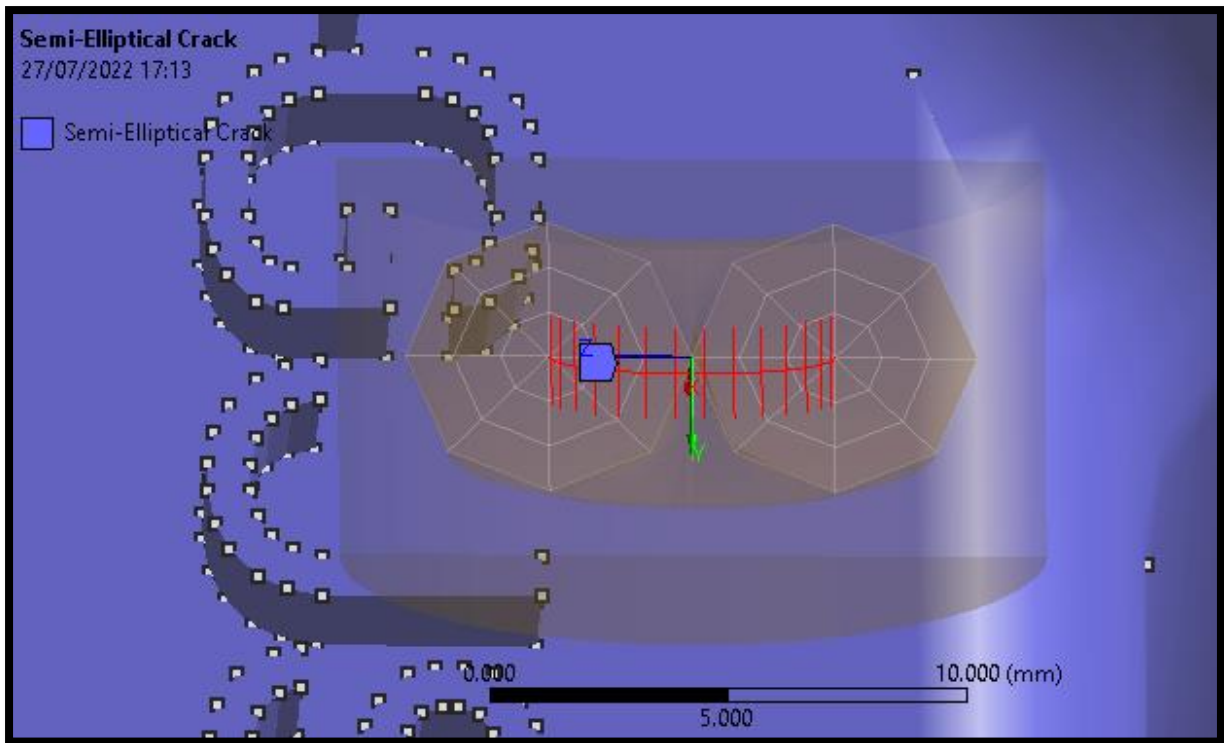
Figure 30: Fracture Geometry and Meshing

Fracture cracks were added to four models to demonstrate the effects of cracking on the ledge surface within the cavity between the mounting holes. All cracks were located on a coordinate system offset from the global coordinate system at X:106, Y: 58.8 and Z: -247. This location was chosen as it represents the rough location of the defect found in Figure 5. The fracture geometry used for the crack was a semi-elliptical crack with a minor radius of 1mm and a major of 3mm. Meshing method for the cracking was hex dominant with three meshing contours around the crack front, see Figure 30.

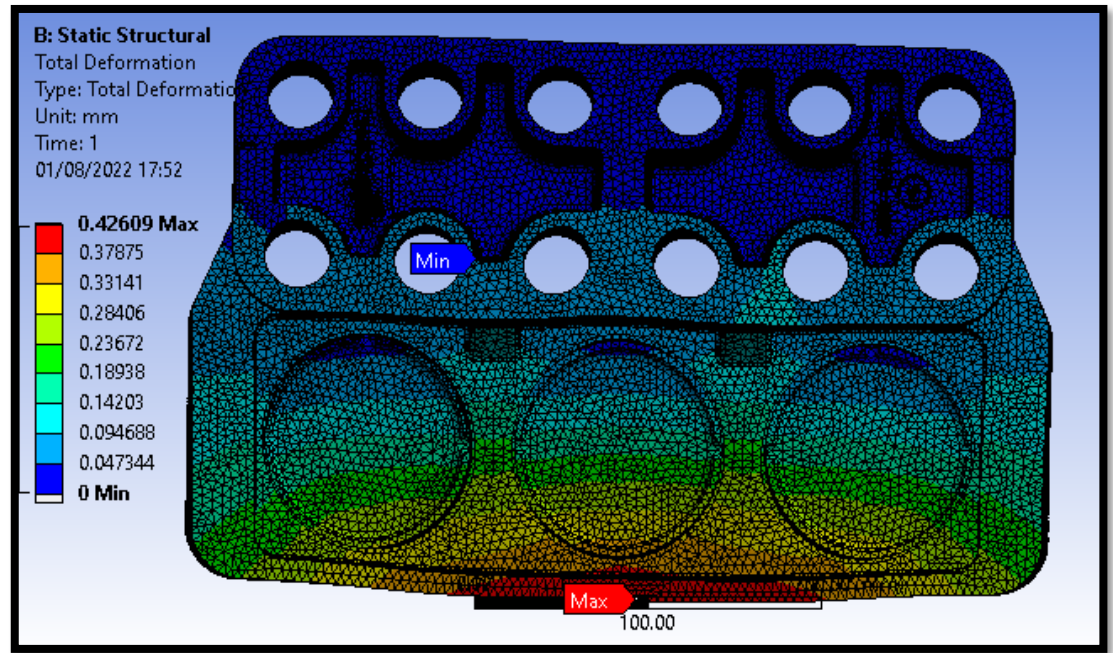
Figure 34: Stamped Caliper Model with Loading 1 - Deformation Result

From Loading 1 there was no evidence of fatigue within the cavity at the holes. This area had the lowest deformation for the whole part, see Figure 34. A stress concentration was noted at the corner near the stamping, see Figure 35, which is at the same location as the suspected crack in Figure 5. Even with this stress concentration no fatigue damage appeared in this area. This would indicate that the component is unlikely to fail at this location. For this loading condition failure was estimated to occur on the underneath of the part at the supporting fins, see Figure 36.

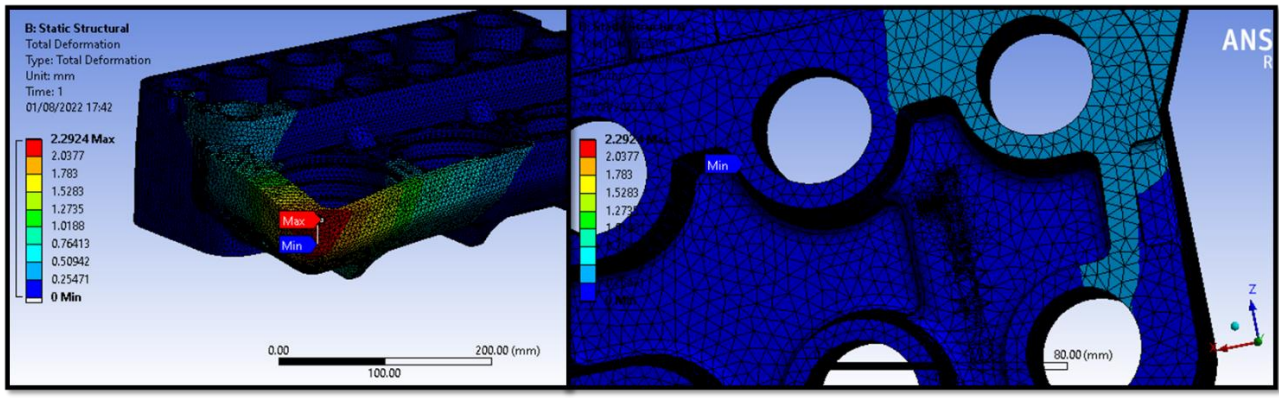
Figure 37: Stamped Caliper Model Loading 2 - Deformation Result

Loading 2 showed a similar story to that of loading 1 in terms of deformation with the ledge surface experiencing the lowest values, see Figure 37. A stress concentration of bigger magnitude was seen in the corner near the stamping, see Figure 38. When looking at fatigue damage Loading 2 resulted in damage being seen on the ledge surface, see Figure 39. However, this was not the only damage area with areas underneath the bores likely to fail first under these loading conditions, see Figure 40. This shows that an undistributed loading would cause failure at the cavity location but under the conditions as per Loading 1 this would not be the case. As

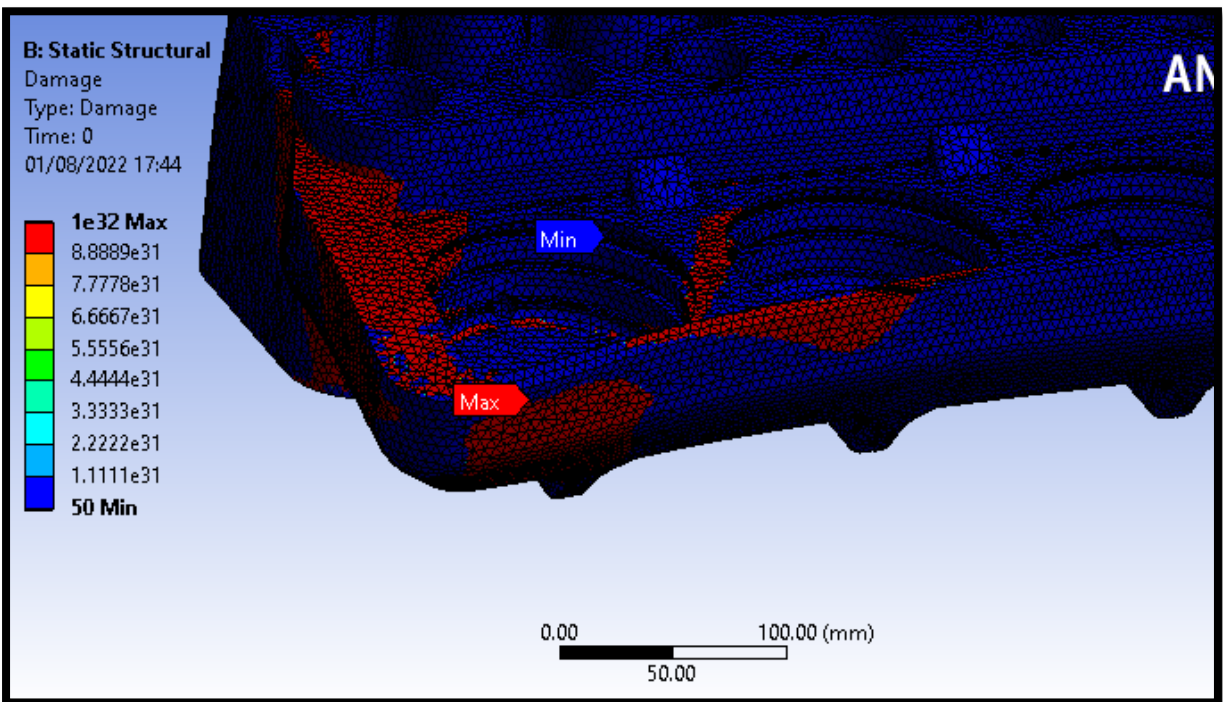
Figure 40: Stamped Caliper Model Loading 2 - Fatigue Damage of Full Component

fatigue failure occurs at stresses lower than that of the materials strength by applying a low load at the position seen in Loading 2 may cause the component to fail as per reported by Renewable Parts Ltd.

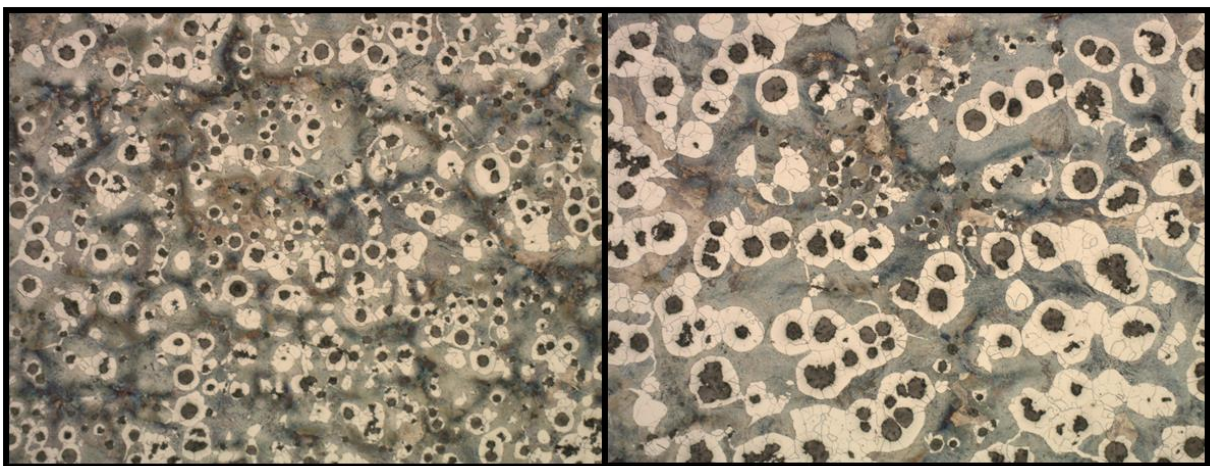
Figure 43: General Microstructure at x50: Left Sample A, Right Sample B

Microscopic analysis was carried out on both samples with the surface layers the area of interest for both. As stated in BS ISO 1082:2018 the general structure in both the samples was a mixture of pearlite and ferrite, see Figure 43. From this it can be seen that the graphite is in spherical form which will decrease the risk of crack formations compared to flake graphite form. The ferrite, in white/ light grey, can be seen to form round the graphite with the pearlite forming around the ferrite.

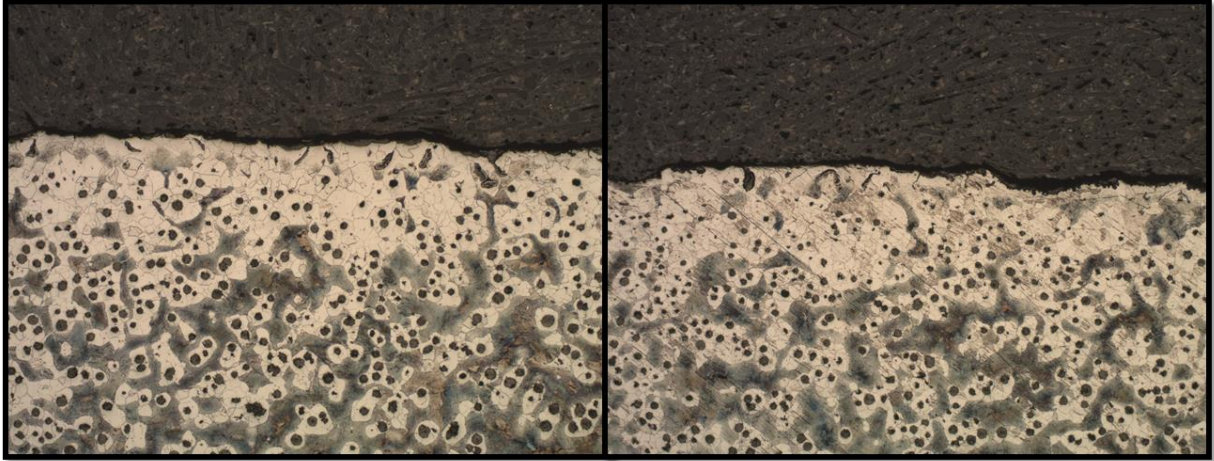
Figure 44: Bore Surface at x50: Left - Untouched Cast Skin, Right - Grounded Cast Skin

Both the untouched surface and grounded surface were looked at to compare the effects of grounding casting defects. From a magnification of x50 it can be seen that at the cast skin the

composition of the material has changed to that of the body with more ferrite and a reduction in pearlite, see Figure 44. There is no sign in the grounded surface having any sort of material property change.

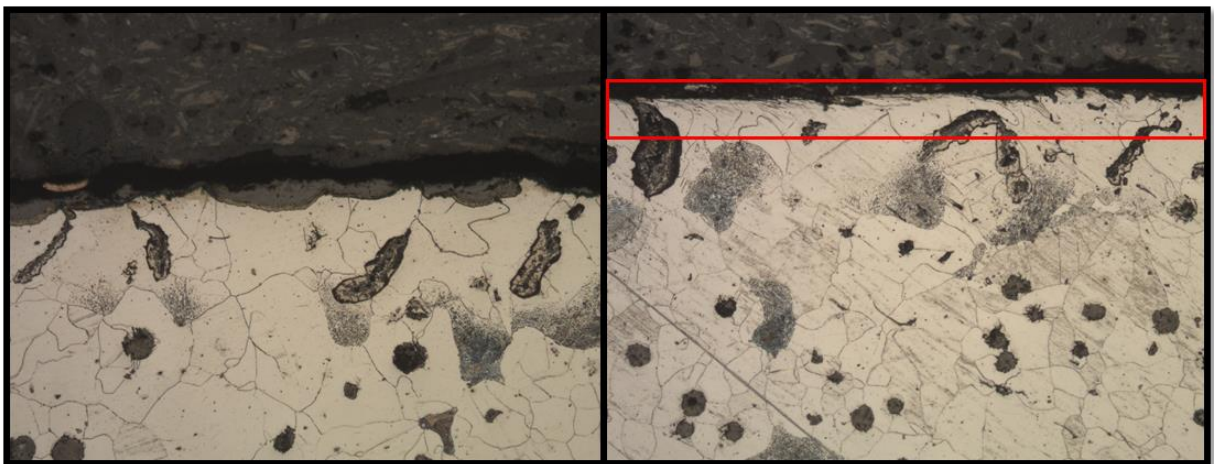
Figure 45: Bore Surfaces at x200: Left – Normal Untouched Surface, Right – Grounded Surface

When looking at a higher magnification of x200 it can be seen that the grounded surface is more flattened compared to the normal surface and there is evidence of the surface being pulled to the left (highlighted in red), see Figure 45. What is also notable is the change in form of the graphite from spherical to flake. Overall there is little affect to the properties of the material from the grinding process. There is evidence of scarring but this is suspected to have little effect of performance. The most interesting observation was the change in structure closer to the cast surface.

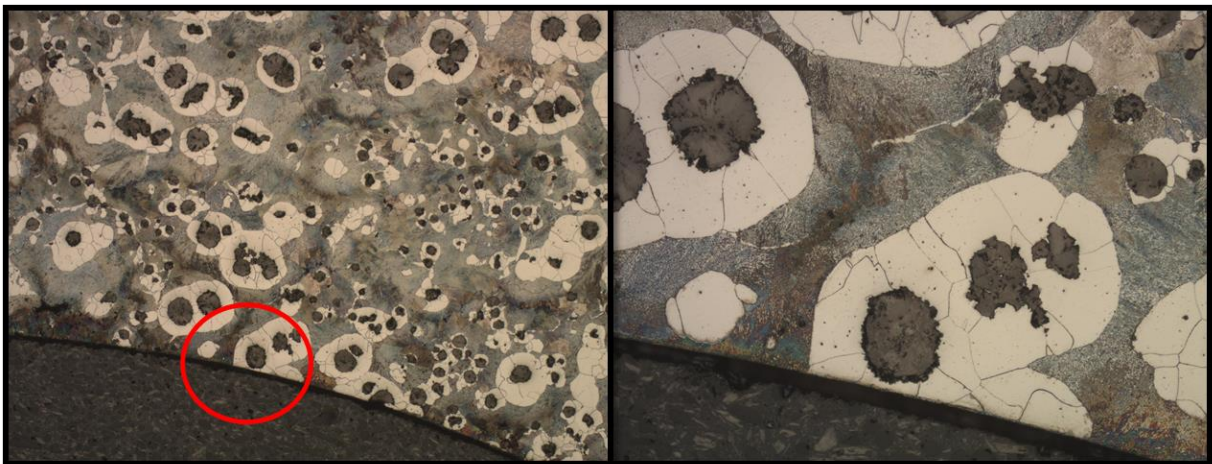
Figure 47: Internal Hole: Left – x50 with Area of Interest Highlighted in Red, Right – Area of Interest at x200

When looking at the internal hole the material structure around it was rich in pearlite, see Figure 47. This was to be suspected due to this being a machined feature through the main body of the component. Cracking in area would be unlikely unless casting defects were present, which in this case they were not.

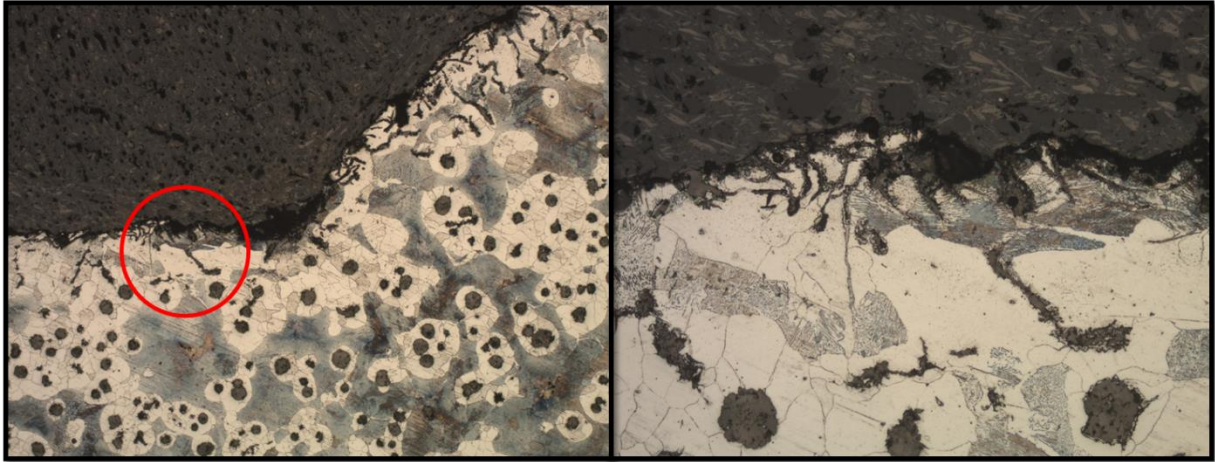
Figure 48: Beginning of Embossed Stamping: Left – x50 with Area of Interest Highlighted in Red, Right – Area of Interest at x200

When looking at the embossed area it was clear again the difference in the cast skin layer to that of the main body, see Figure 48. Flake graphite was heavily present with areas having

graphite in a perpendicular direction to the surface. These areas are prime location for the formation of fatigue cracking as an easy access route into the materials structure. The corner at the start of the stamp was hard to see but as this would likely be an area on high stress concentration it was examined further via Scanned Electron Microscopy (SEM).

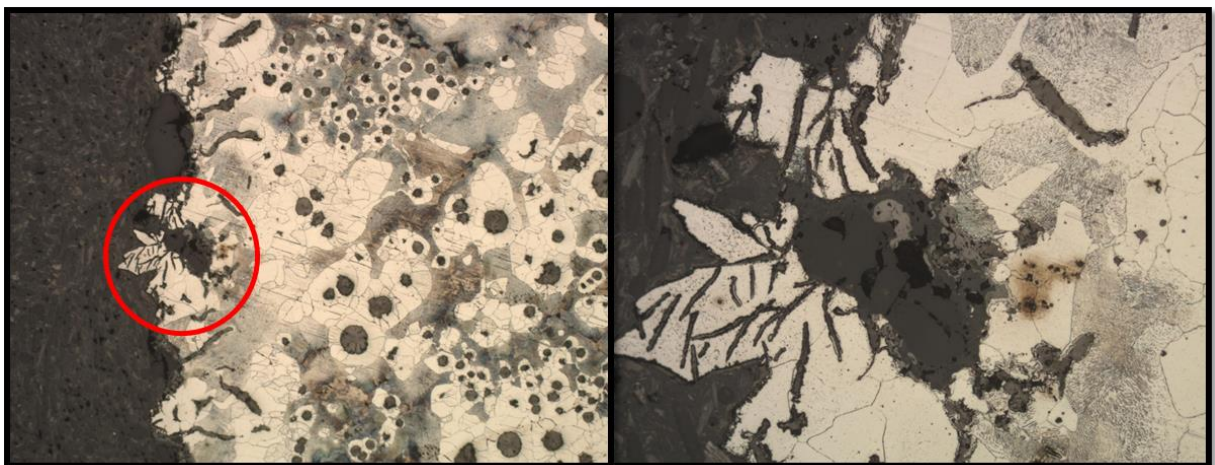
Figure 49: Side Surface: Left – x50 with Area of Interest Highlighted in Red, Right – Area of Interest at x200

The lowest quality of the cast skin was found at the side surface of the sample, see Figure 49, which is the exposed vertical cast surface inside the cavity. Surface roughness was clearly high and more flaking was present compared to that in the embossed surfaces. An anomaly was spotted in the material which seemed to have penetrated the material surface. This was suspected to be a grain of sand from the casting process but due to the limitation of optical microscopy a conclusion could not be made. As a result, this area was also examined further via SEM.

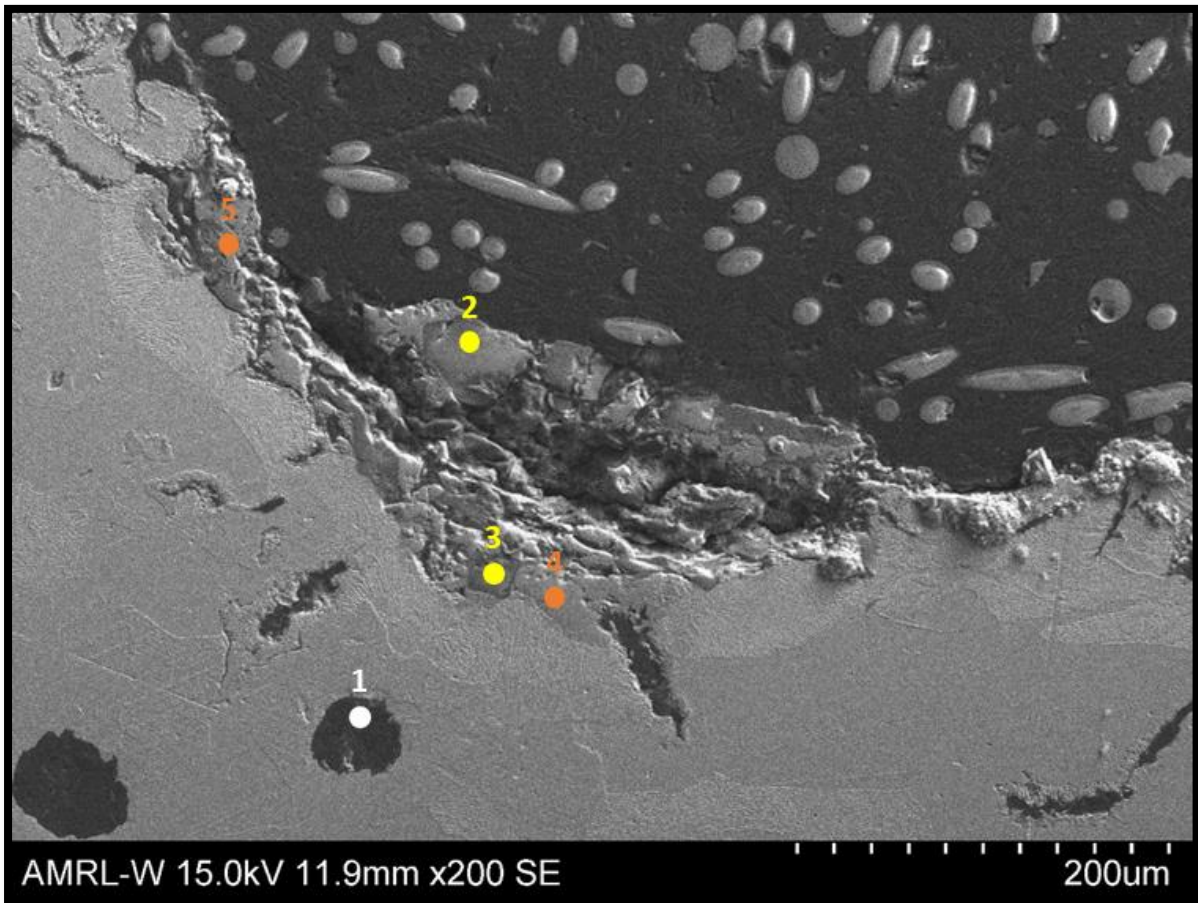
Figure 51: Embossed Stamp Corner at x200

The first area looked at was the embossed corner area, see Figure 51. Graphite (White) was detected at point 1. Points 2 and 3 showed the presence of silica oxide (Yellow), also known as sand. This was surprising as it was not expected that sand particles would be present in this area. At points 4 and 5 Iron Oxide (Orange) was present this means that corrosion of the material has begun on the surface. This can weaken the material and can be utilised for crack initiation and growth. Flake graphite normal to the surface can be seen here as well; which can further entice growth due to the orientation as slip plane deformation occur normal to the surface during the early stages of a cracks life.

- If crack initiation has started within the cavity surfaces but has not begun to propagate into the material the cast surface in this area should be removed. This could be done via a process such as sand blasting. This will remove the weak cast surface layer and avoid cracking into the bulk of the material. It is also recommended that a surface protection coating is applied to reduce risk of corrosion after the removal of this surface. This could be either via paint or a chemical conversion coating as they can be applied easily.

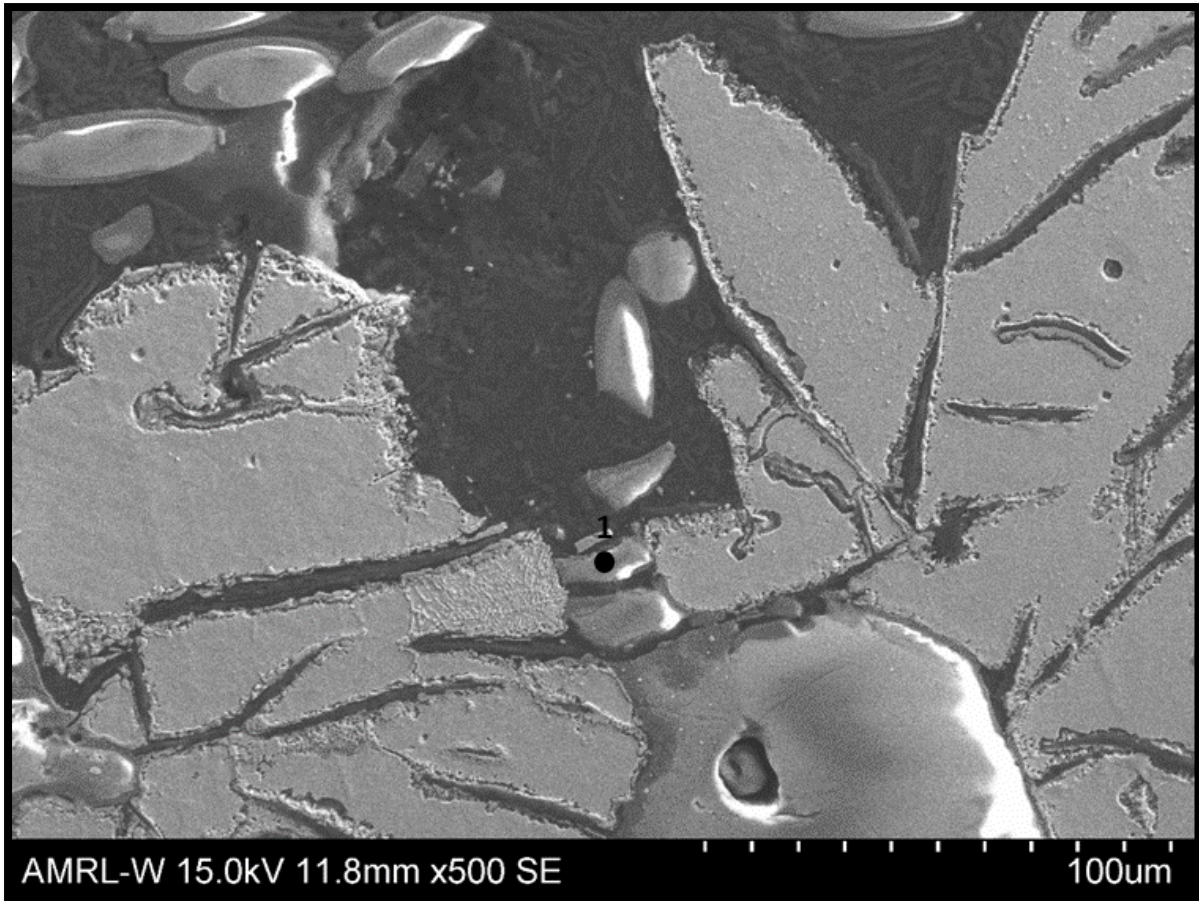
Figure 53: Side Surface Next to Suspected Sand Grain at x500

Looking closely at the opening of where the sand grain is was discovered that the Bakelite material had flown into the opening, see Figure 53. This highlights a potential area where cracking could begin. With iron oxide present within the material surface this can provide a route for cracking initiation into the material.

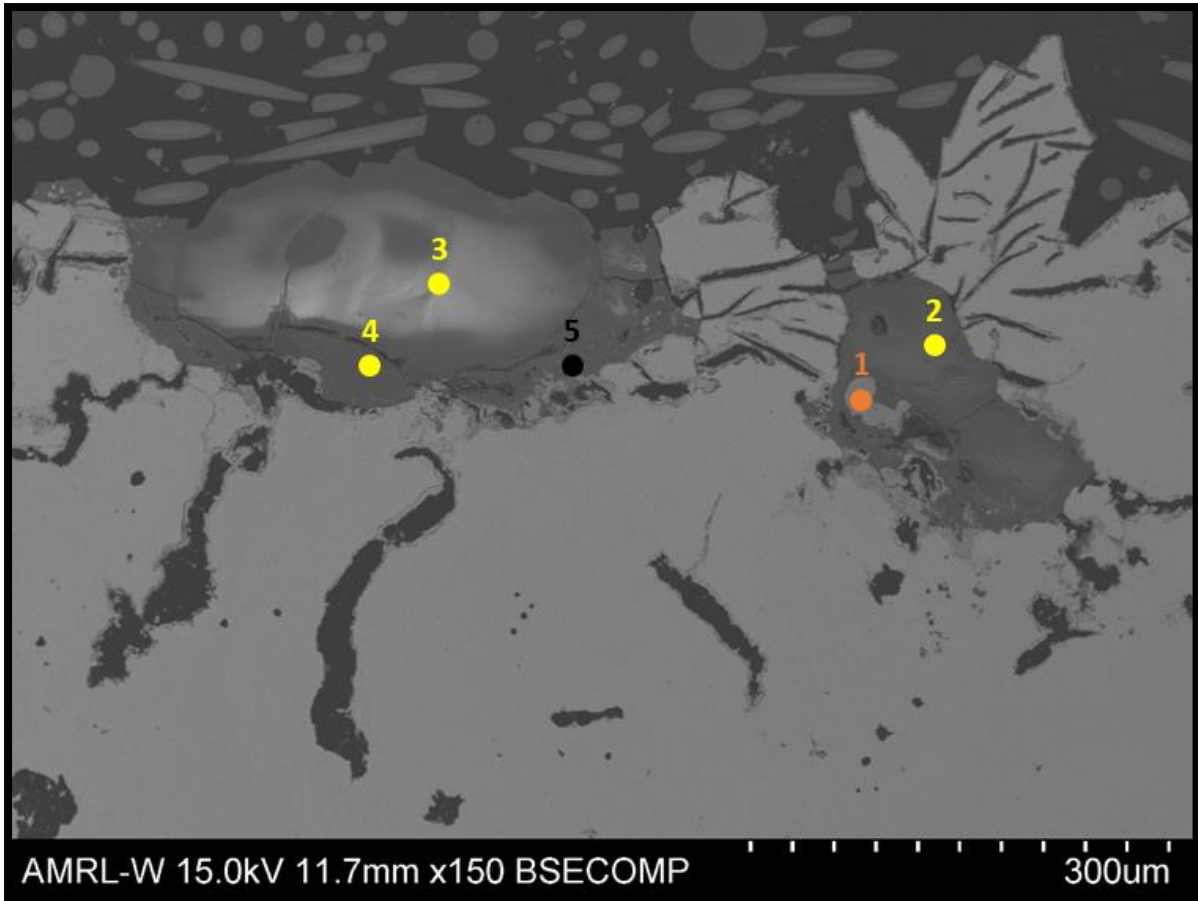
Figure 54: Side Surface Showing Both Suspected Sand Grains at x150

Figure 54 details a view of the two suspected sand grains found during microscopy. Points 2-4 reinforce earlier imagery that these areas are silica oxide. Point 1 shows the extent of which the iron oxide is present at this location in the material. Point 5 was found to be Bakelite. This is another example of there being openings formed between the material surface and the sand. This surface geometry is again an opportunity for cracks to form and work through the weaker flake graphite present in the cast skin before propagating through the material.

skin which is more subjectable to cracking due to its form. Sample B also showed sand grains being stuck to or into the surface of the cast skin with iron oxide underneath. This could be a result of oxygen being trapped in between the grain and surface causing corrosion to start.
